PROPERTY INSPECTION REPORT

For The Property Located At
1035 Presidio Drive, San Diego, California 92131

Property Address:	1035 Presidio Drive
Property City:	San Diego
Property State:	California

Inspection Date:	04.02.2018
Inspection Start Time:	09:00:00 AM
Inspection End Time:	12:00:00 PM
Inspection Weather:	Clear and Dry
Inspection Temperature:	75 degrees

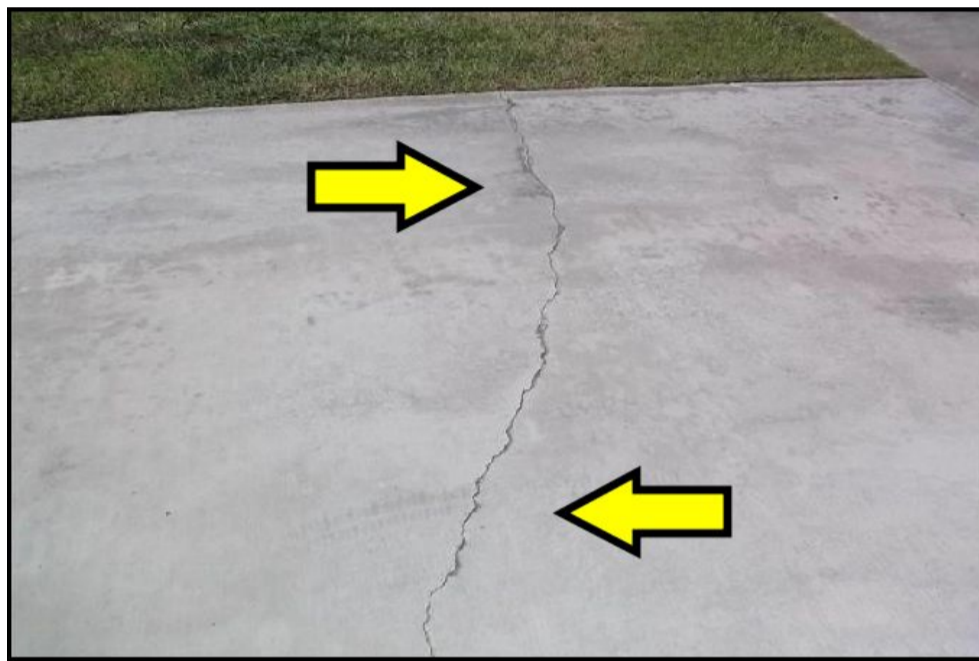
NEEDS ATTENTION 1.1. There is cracking in the driveway up to 1/16" in width the cause of which we are unable to determine. The most common causes of this are relatively benign conditions (e.g. poor construction, age, roots).

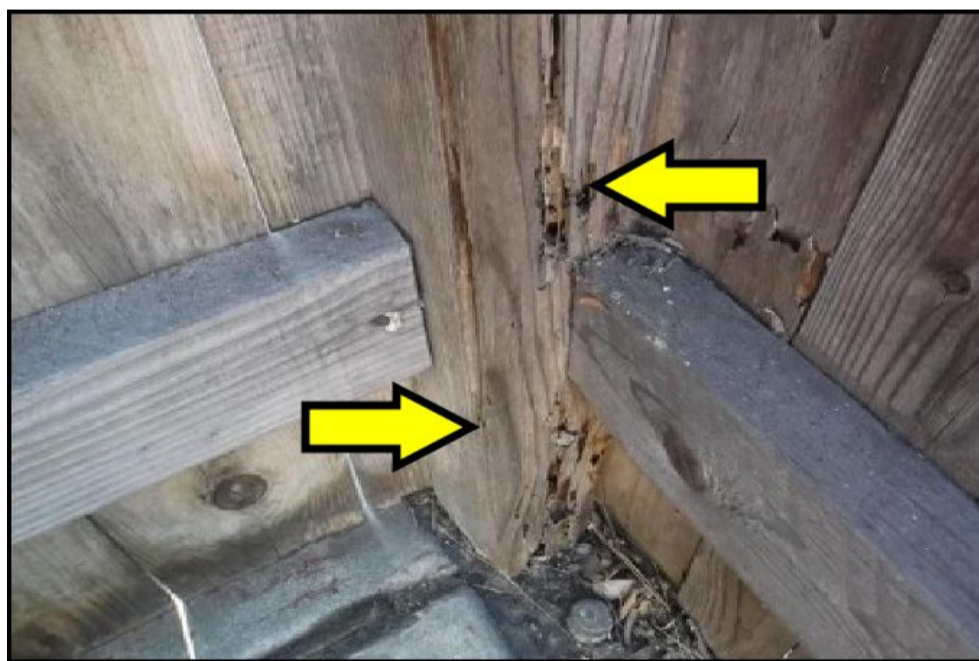
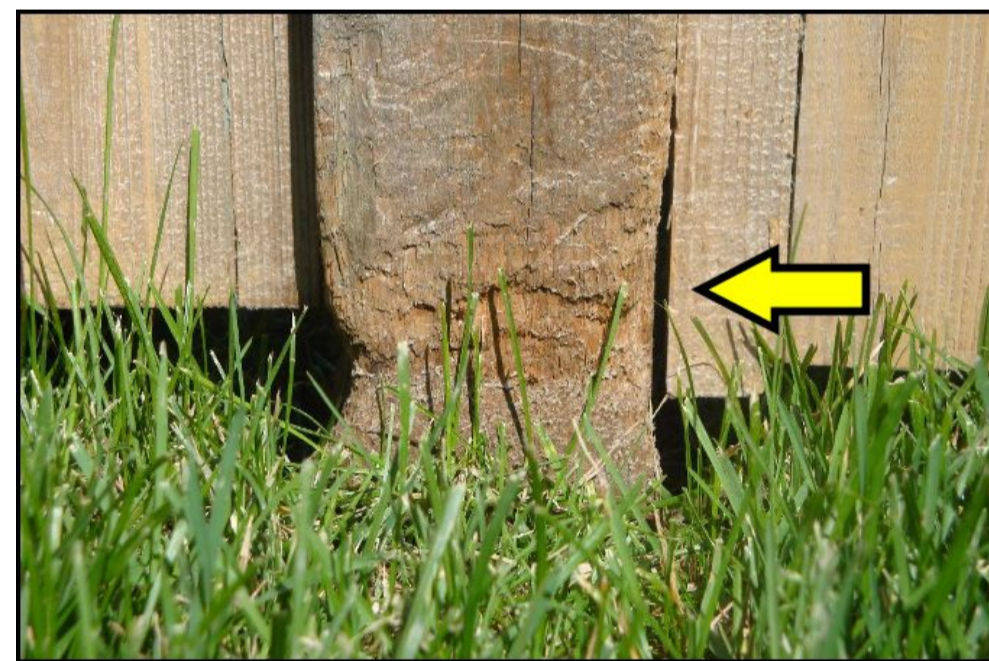
NEEDS ATTENTION 1.3. Portions of the wood fence posts are rotted or in a deteriorated condition. This renders the fencing unstable and/or weakened. Location: multiple areas.

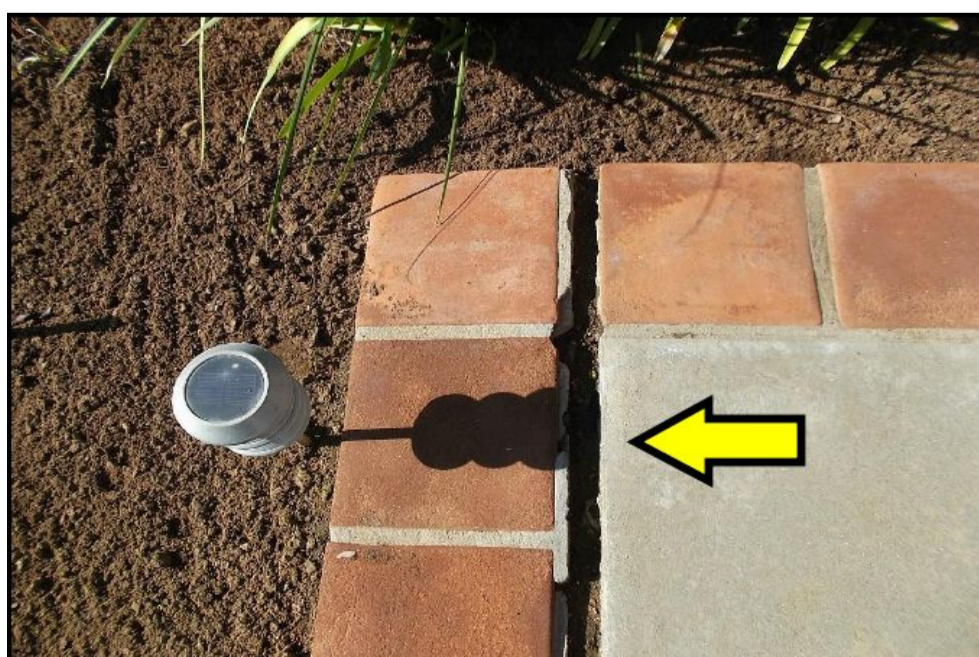
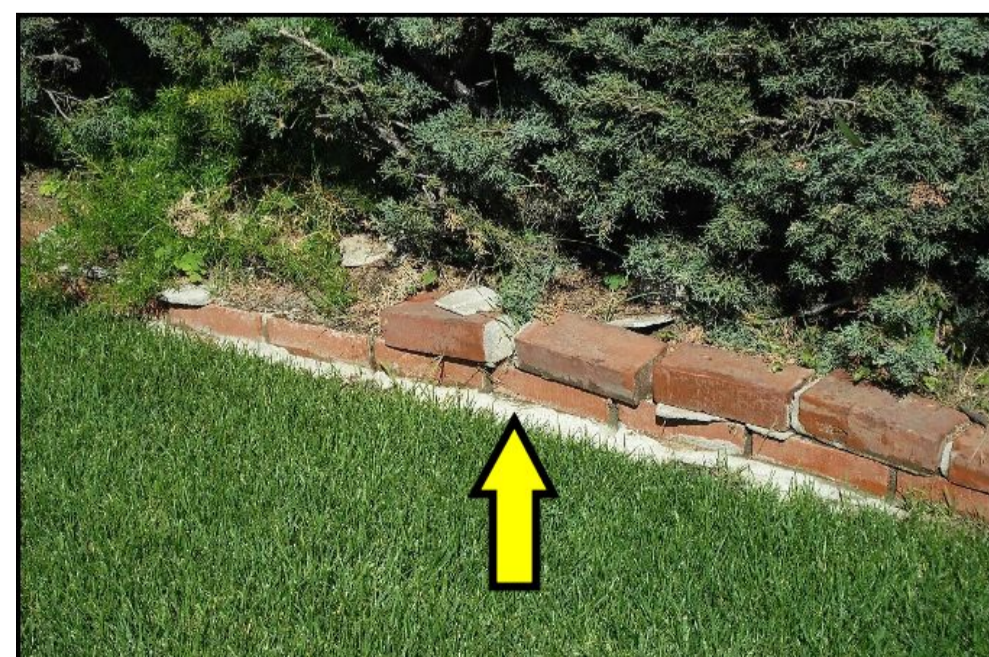
NEEDS ATTENTION 1.4. Two brick planter walls are in disrepair: the left side brick planter wall has a separation crack; the backyard planter wall is partially collapsed.

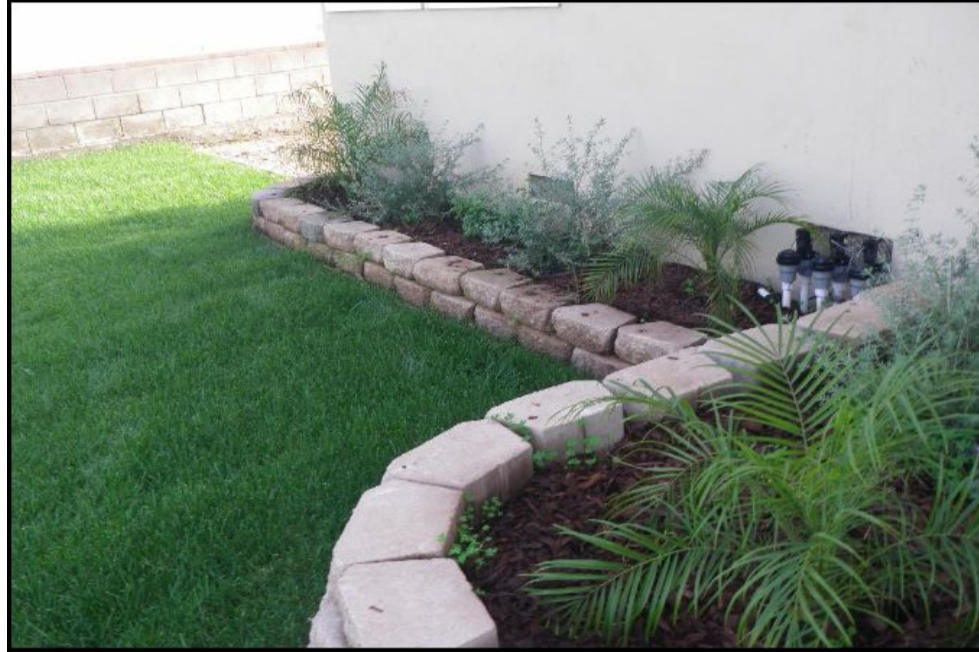
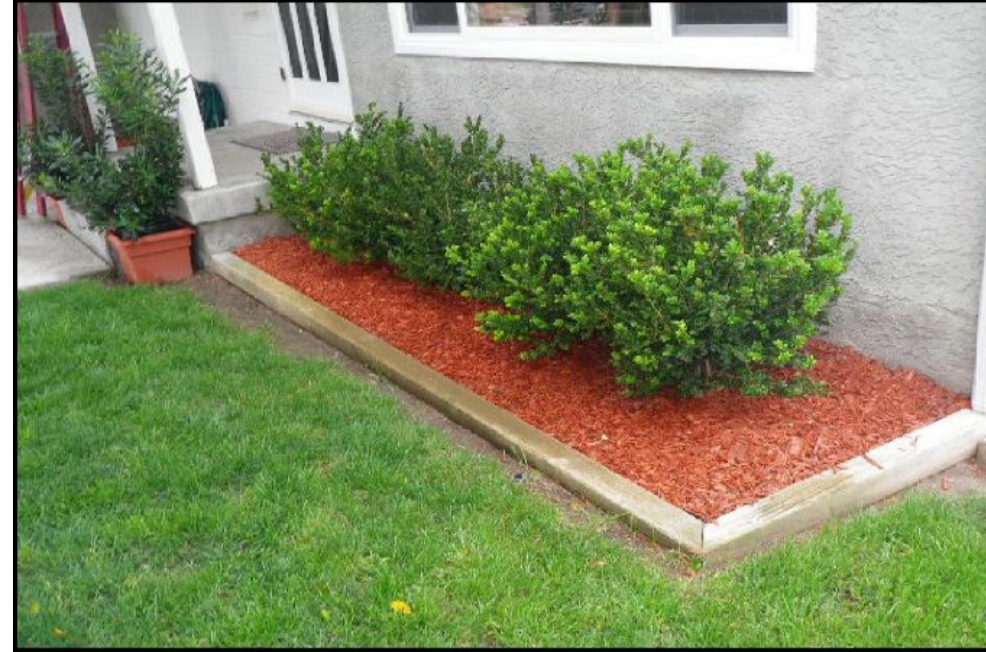
NEEDS ATTENTION 1.6. There are one or more planters, either above grade or at grade level, that are located adjacent to the structure. This can lead to moisture intrusion, mold growth and damage to the foundation in some cases. Note: further evaluation by a foundation contractor is recommended to rule out any moisture intrusion issues in visually inaccessible areas.

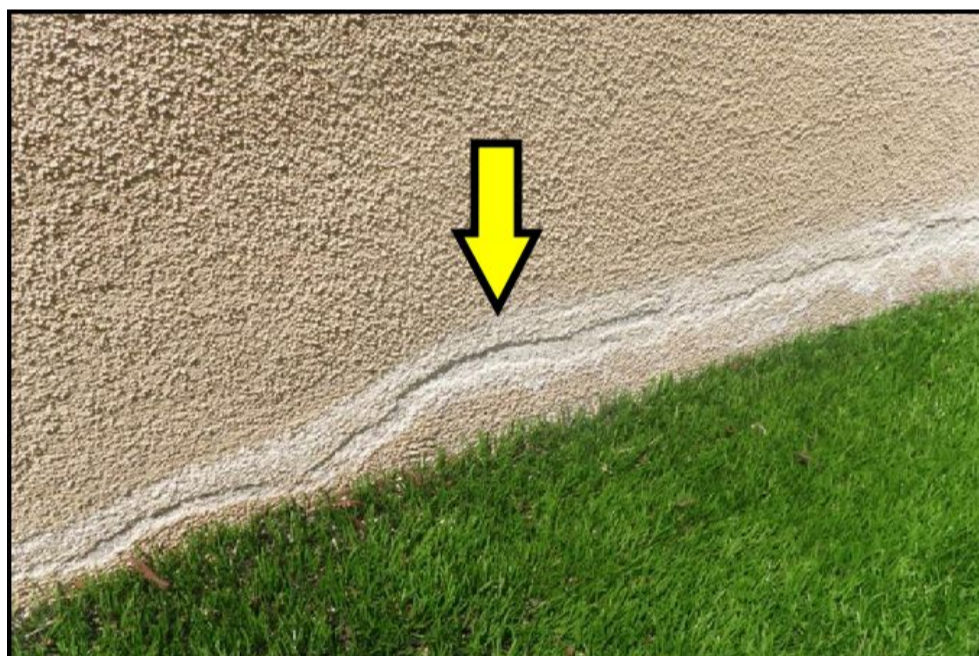
NEEDS ATTENTION 1.7. There are cracks in the stucco finish that are up to 1/16" in width. Although stucco cracking of this nature may be the result of benign conditions (poor construction, age, minor settlement), the limited scope of a home inspection precludes the inspector from being able to rule out other causes of a potentially serious nature (e.g., unstable or expansive soils adversely impacting the structure).

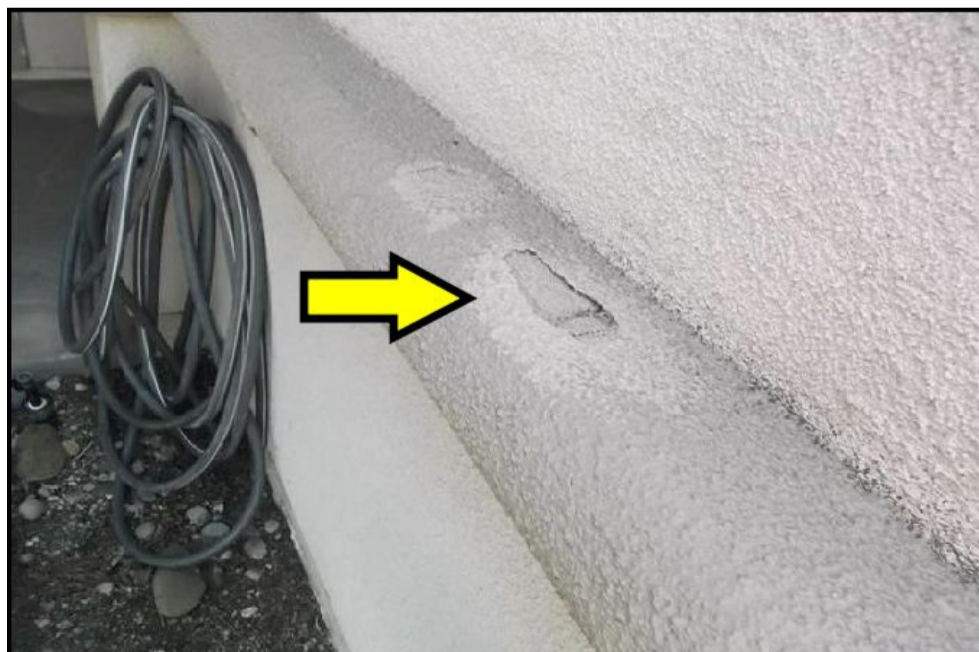
NEEDS ATTENTION 1.8. The inspector observed areas of patching to the exterior stucco wall(s). Although stucco patching is not uncommon, we recommend you obtain an independent determination if possible as to what underlying stucco condition was addressed by the patching, and when the wall repair was performed, in order to rule out anything structurally significant about the patching. Location: Rear side.

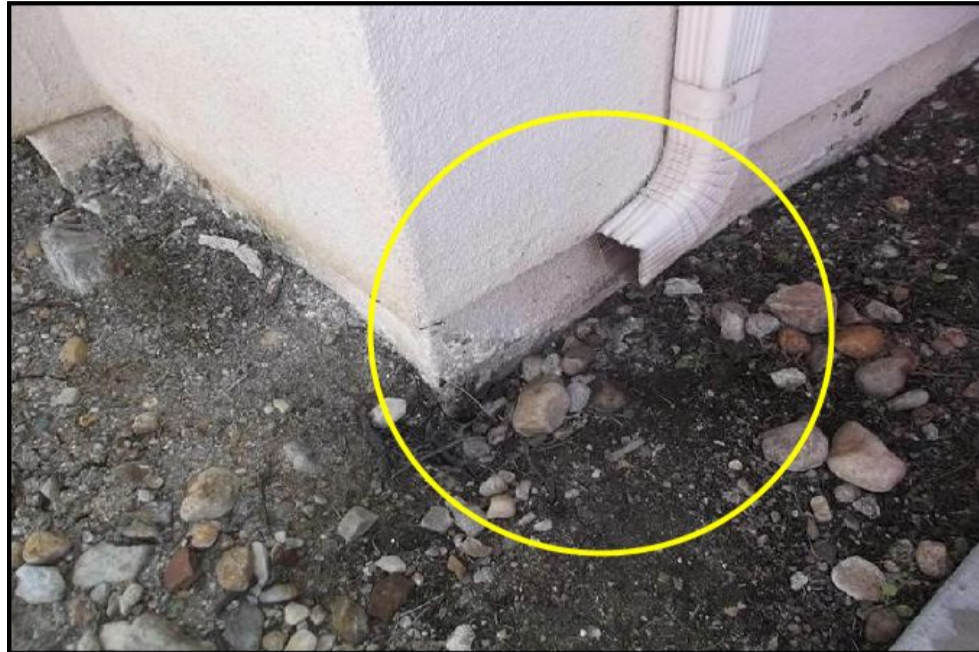
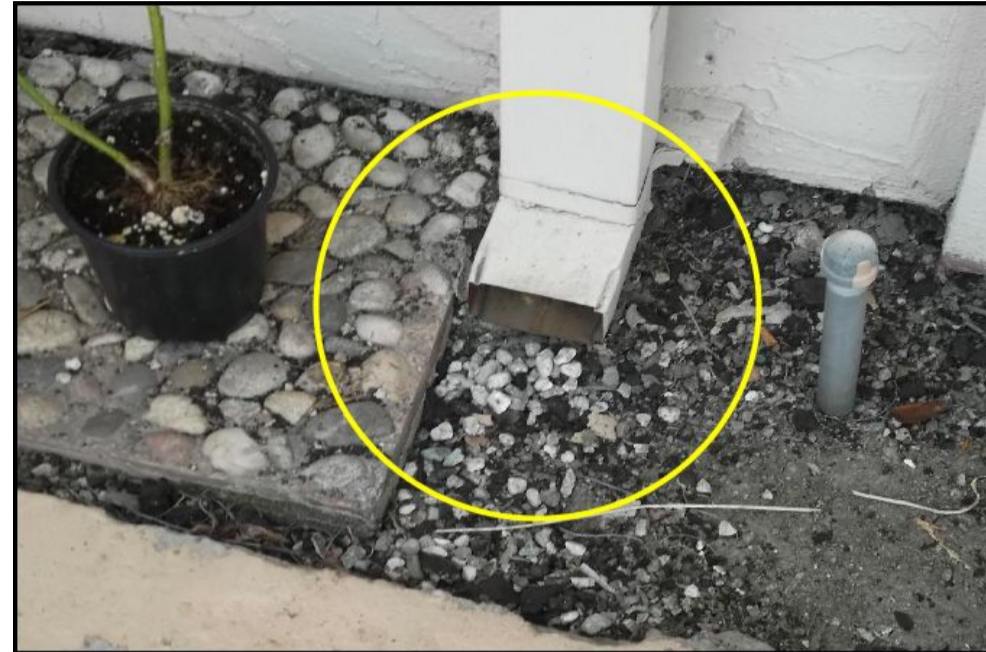
NEEDS ATTENTION 1.10. There are two downspouts that discharge roof runoff water too close to the foundation. Keeping water away from the foundation and walls is important to prevent moisture intrusion damage to the home's foundation and surrounding components. **Note:** further evaluation is recommended since inspection for possible water damage to visually inaccessible portions of the structure is not within the scope of the inspection. Location: Left and rear sides.

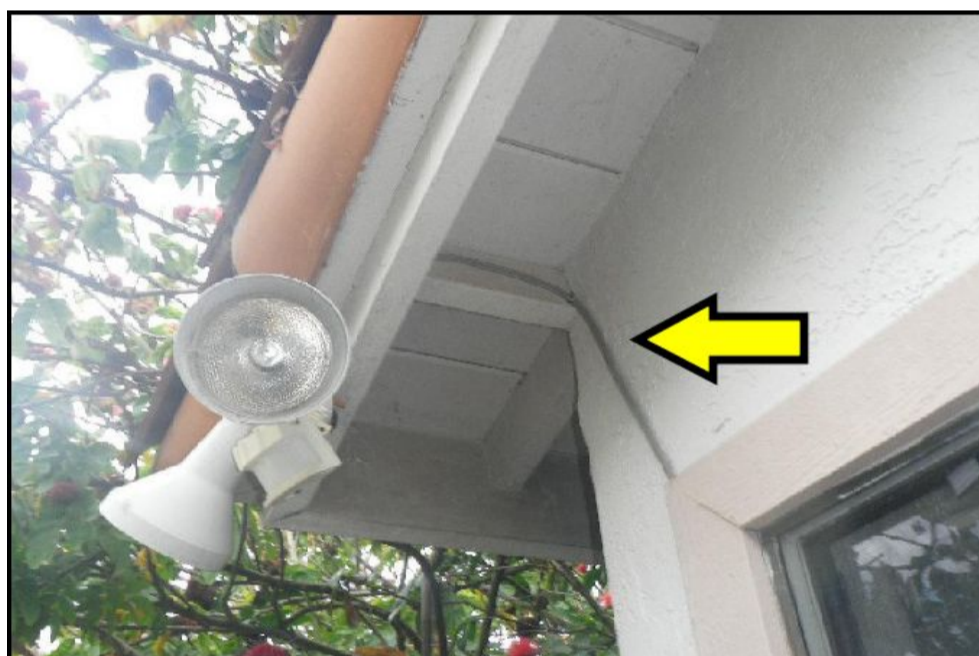
NEEDS ATTENTION 1.12. There is romex wiring at the exterior of the structure that is not rated (i.e. improper) for exterior use or, because of its location, is required to be run through approved conduit. Location: Right side.

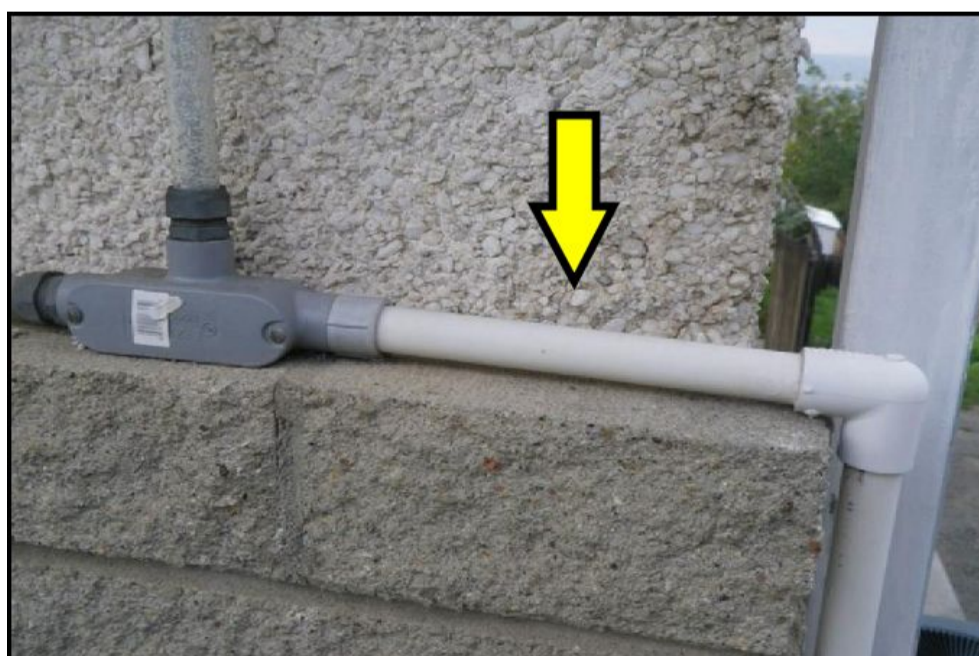
NEEDS ATTENTION 1.13. The white PVC conduit (pipe w/ wire inside) installed to the left of the rear deck and patio area is not rated for exterior use and should be replaced with exterior rated conduit.

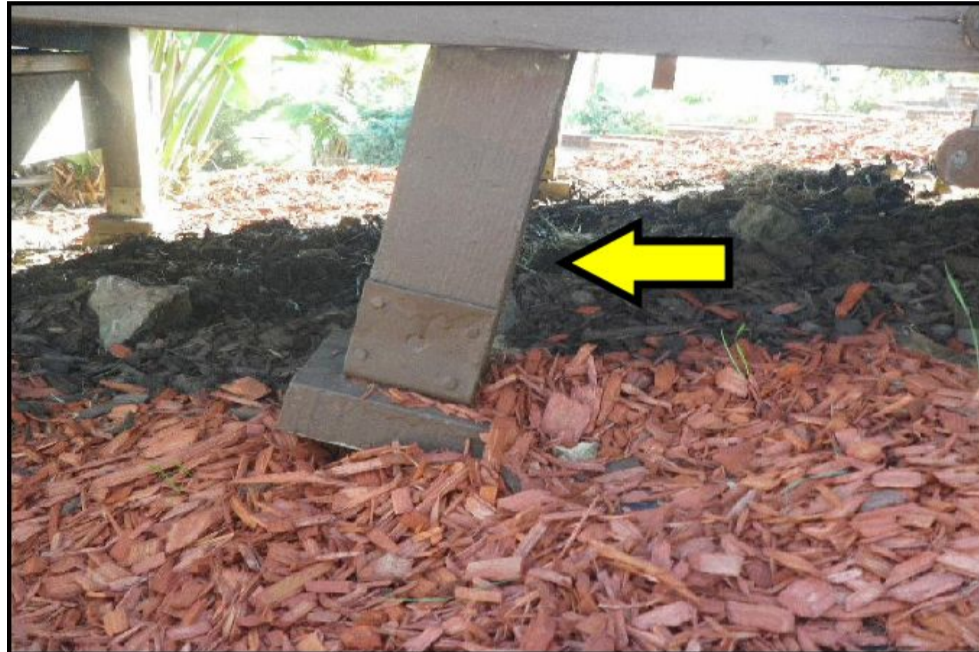
NEEDS ATTENTION 1.18. The deck framing is deficient. One of the posts supporting a beam is leaning and failing to provide the necessary support for the deck framing. A qualified licensed contractor should be consulted for repair options and costs.

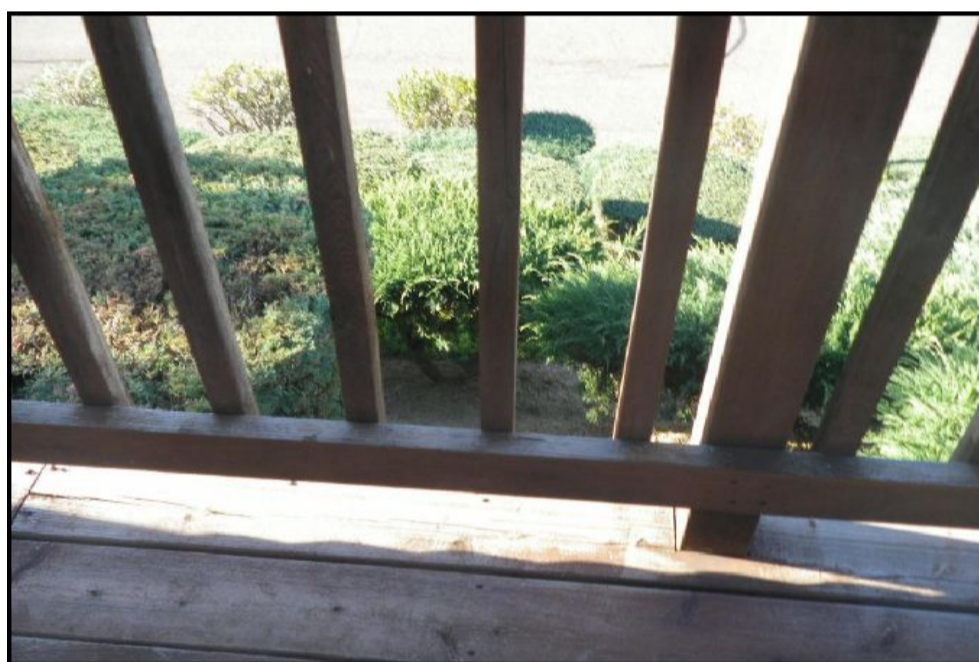
NEEDS ATTENTION 1.19. The deck hand railing has openings in it greater than 4" wide. We recommend correction of this condition to ensure the safe use of the deck/balcony (for child safety reasons). Location: Left side.

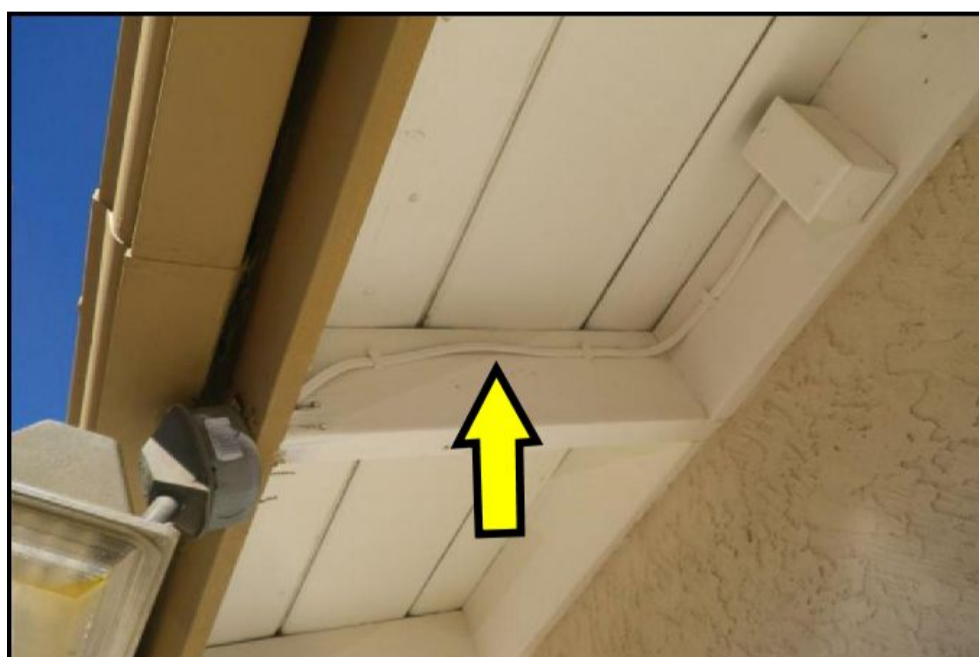
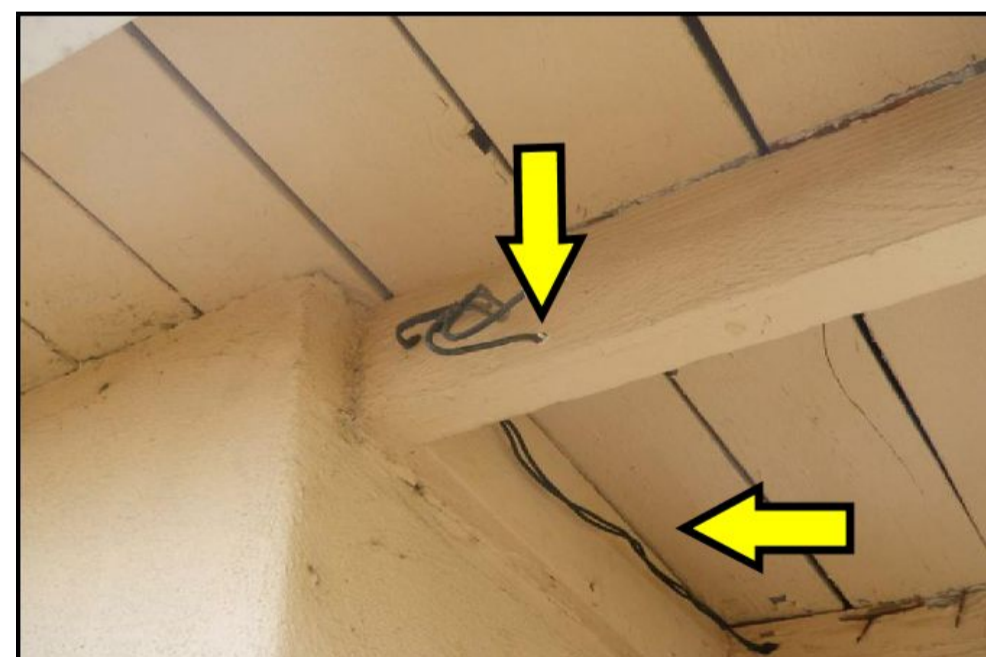
NEEDS ATTENTION 1.20. There is romex wiring in the deck/balcony in two different areas that is not rated (not proper) for exterior use. We recommend replacing this with a proper exterior wiring method.

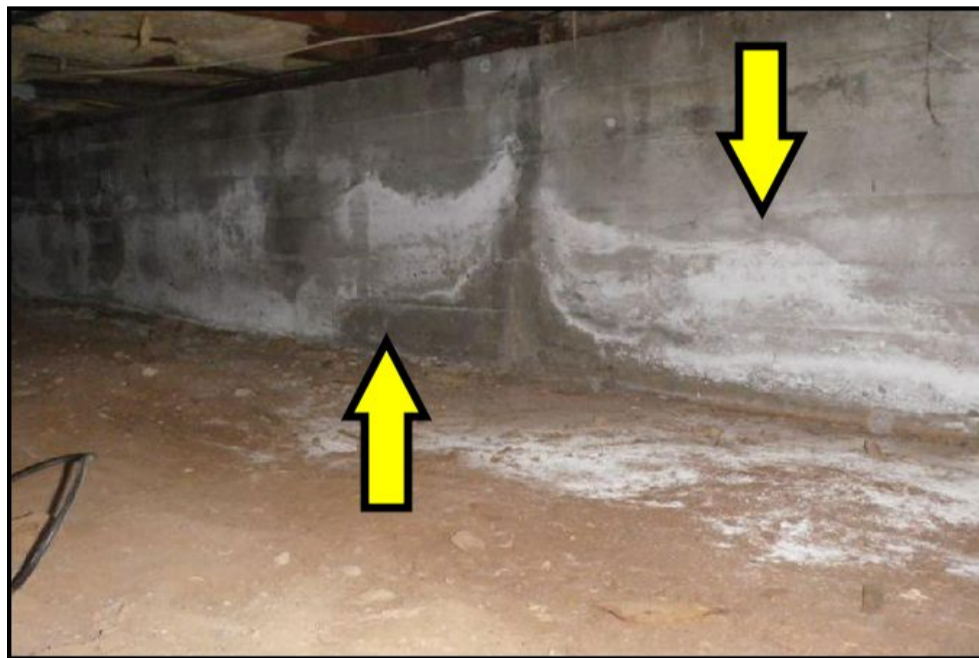
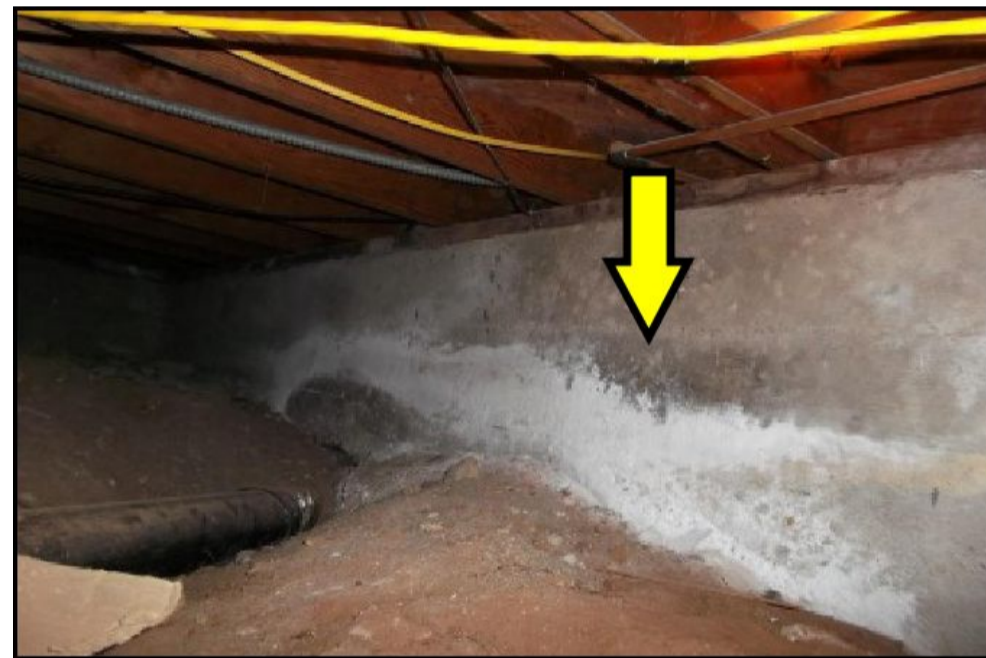
NEEDS ATTENTION 2.2. Some efflorescence was observed on the surface of the stem wall. and the soil. Efflorescence is a white powdery substance which forms on concrete-masonry surfaces when exposed to moisture. Although commonly found, this condition has been known to deteriorate the concrete/masonry foundation wall(s). Further evaluation by a foundation contractor is recommended should you wish to rule out the presence of any moisture intrusion problems (e.g., damage, improper lot drainage, damp conditions, insufficient ventilation).

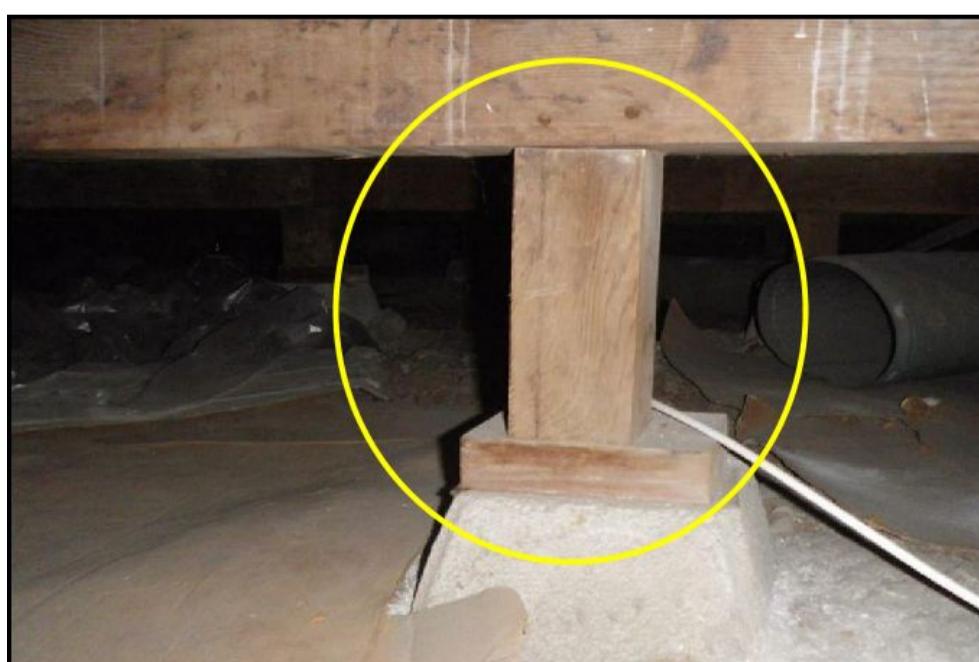
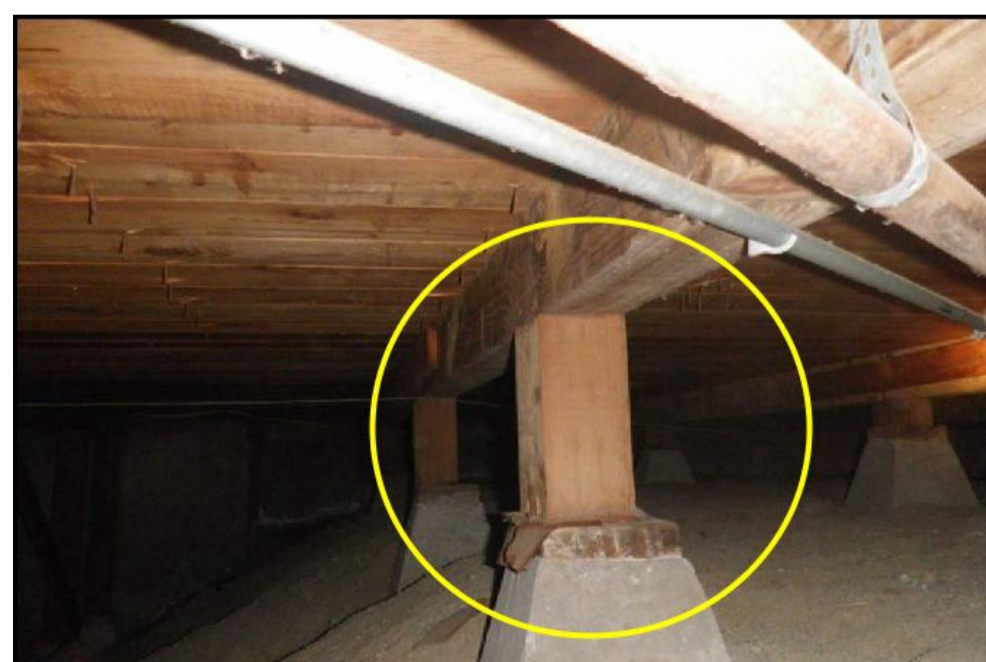
NEEDS ATTENTION 2.4. The wood posts supporting the sub-floor framing are not strapped to the piers nor to the support beams. Although this may not have been required at the time the house was constructed, posts should be properly strapped (connected) to increase stability and help reduce damage in the event of an earthquake. We suggest a foundation contractor further evaluate the foundation components for repair recommendations and costs.

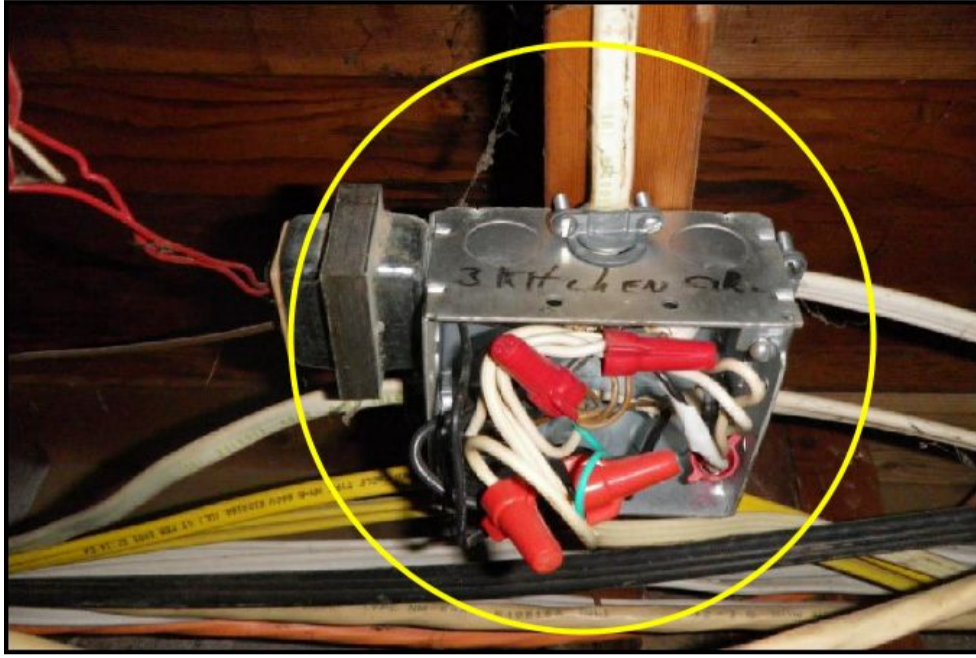
NEEDS ATTENTION 2.6. There is an electrical junction box in the crawl space lacking a cover plate. A cover plate should be installed as it provides protection from shock hazards and protects the wiring from the surrounding environment.

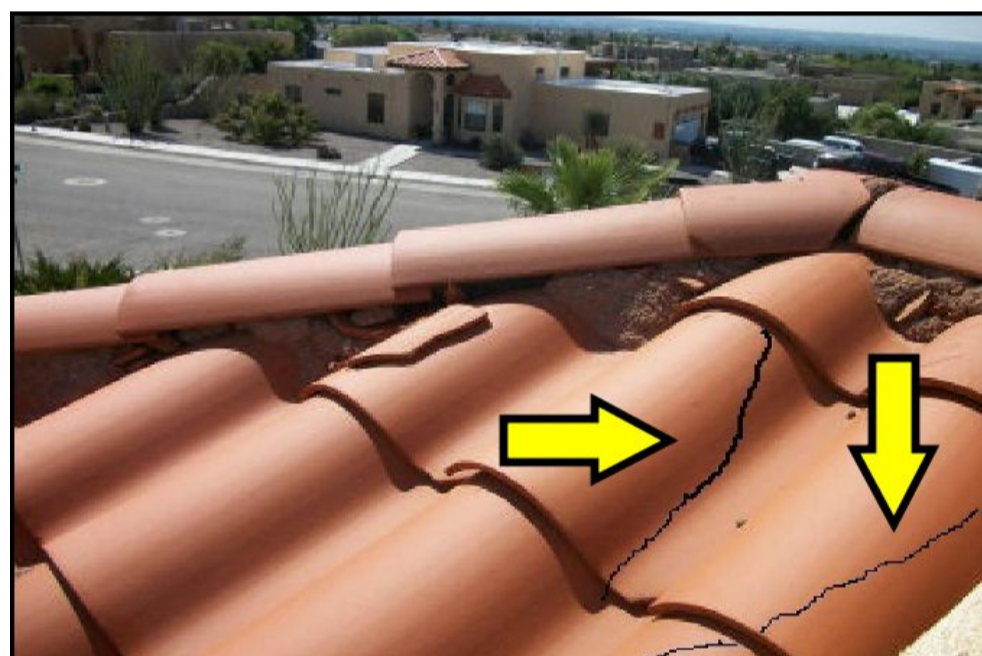
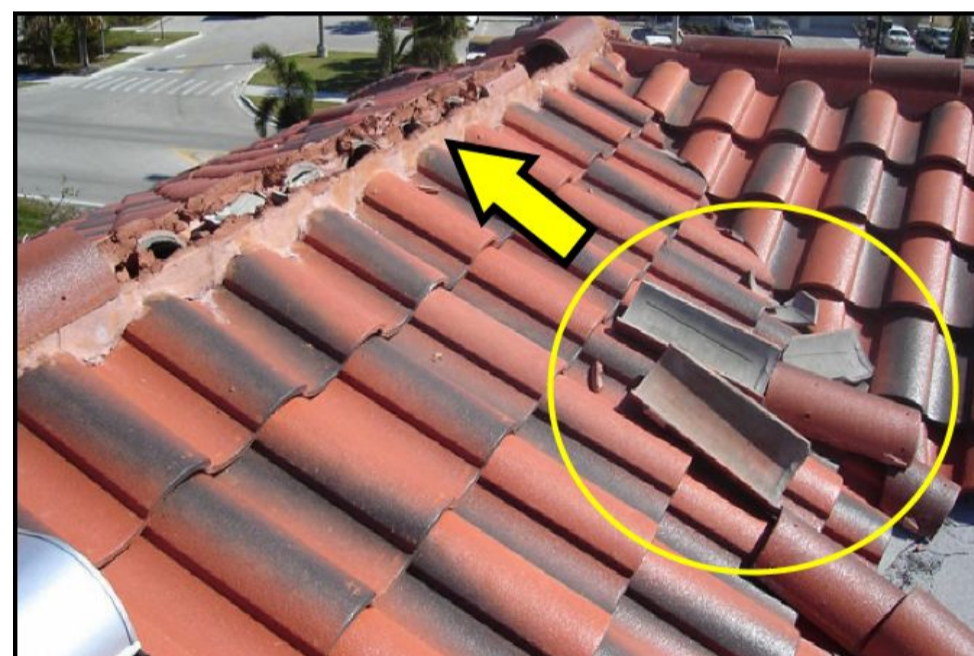
NEEDS ATTENTION 3.4. Cracked tiles were observed at the top rear section of the roof. Additionally, several "cap" tiles have become dislodged from the top of the roof. Recommend repairs as these conditions increase the roof's susceptibility to leaks. Approx. number: 5-10.

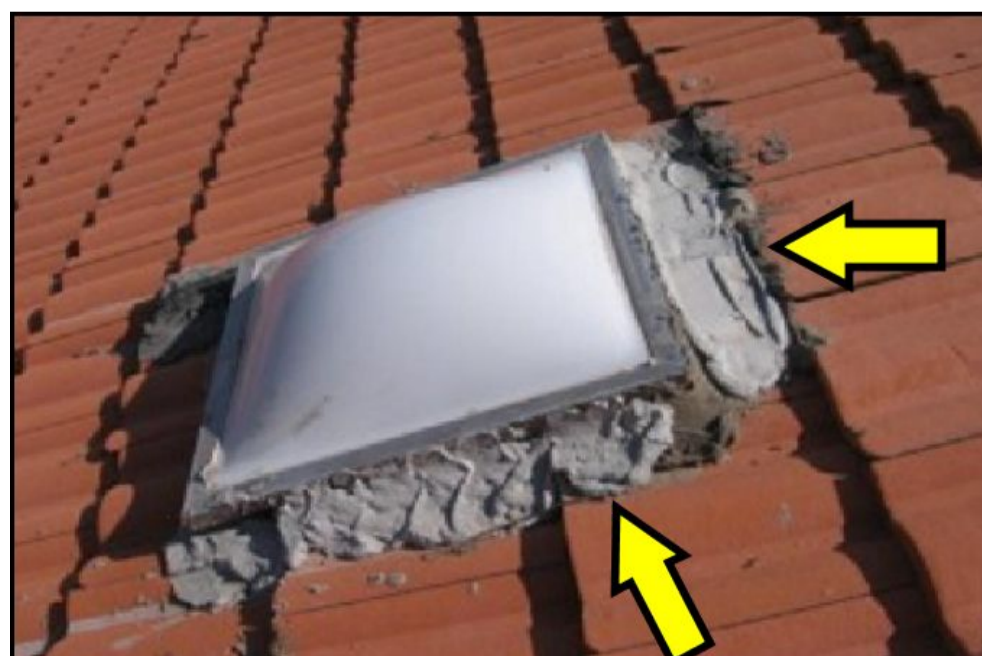
NEEDS ATTENTION 3.6. The inspector found the skylight to have been constructed or installed in a sub-standard manner (excessive use of mastic). Skylights that fail to conform to construction standards enhance the likelihood of leakage.

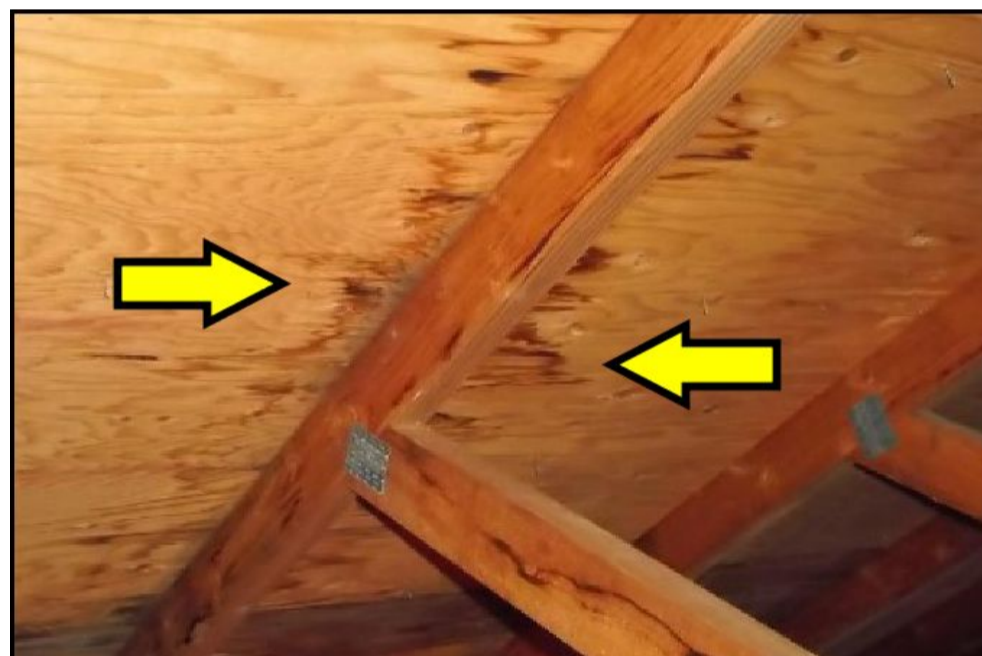
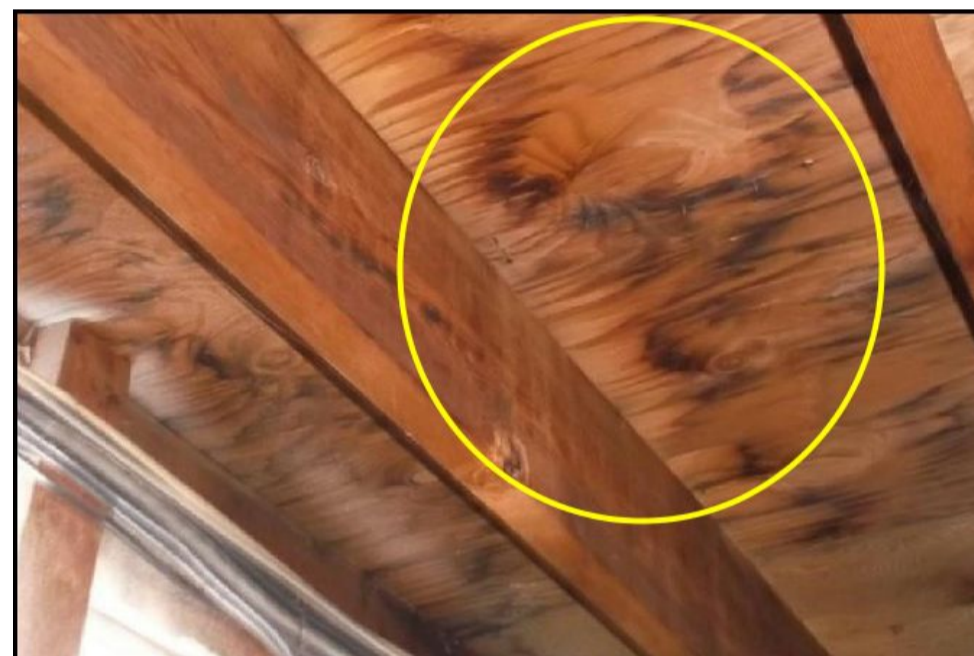
NEEDS ATTENTION 4.2. There are moisture stains and/or sufficient evidence of prior roof leakage on the underside of the roof. Stains are indicative of a current or prior roof leak. Since your inspector cannot determine if the leak that caused the staining has been remedied, further evaluation of the roof by a roofing contractor is advisable.

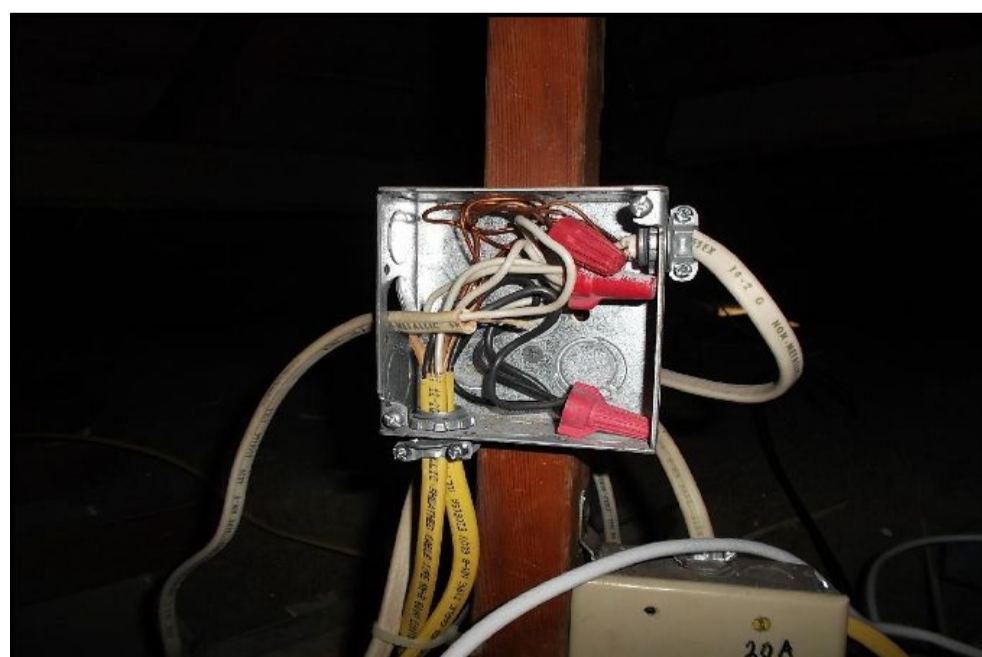
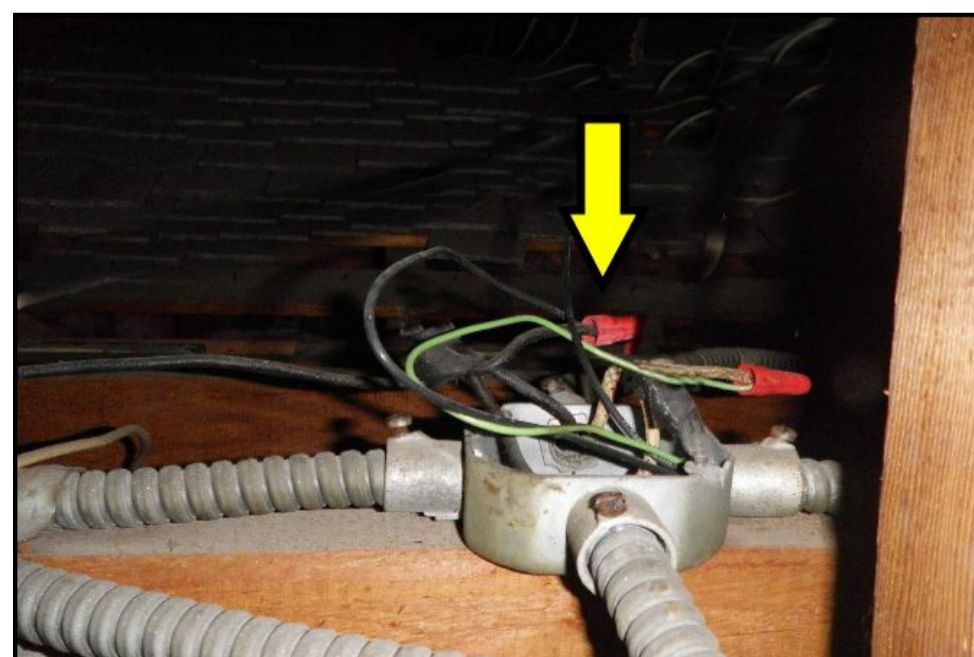
NEEDS ATTENTION 4.6. The inspector observed two open electrical junction boxes in the attic that should be sealed so that any arcing or sparking is contained within the box.

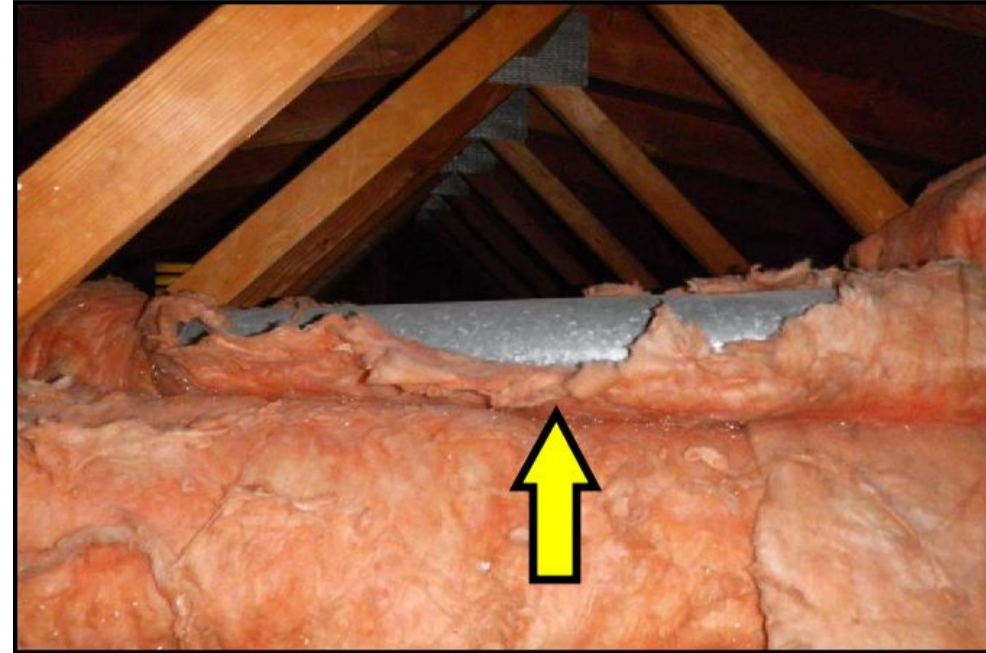
NEEDS ATTENTION 4.7. Some portions of the air distribution ducts in the attic have missing insulation. Further evaluation may include a recommendation for repair or replacement to enhance energy efficiency of the HVAC system, among other reasons.

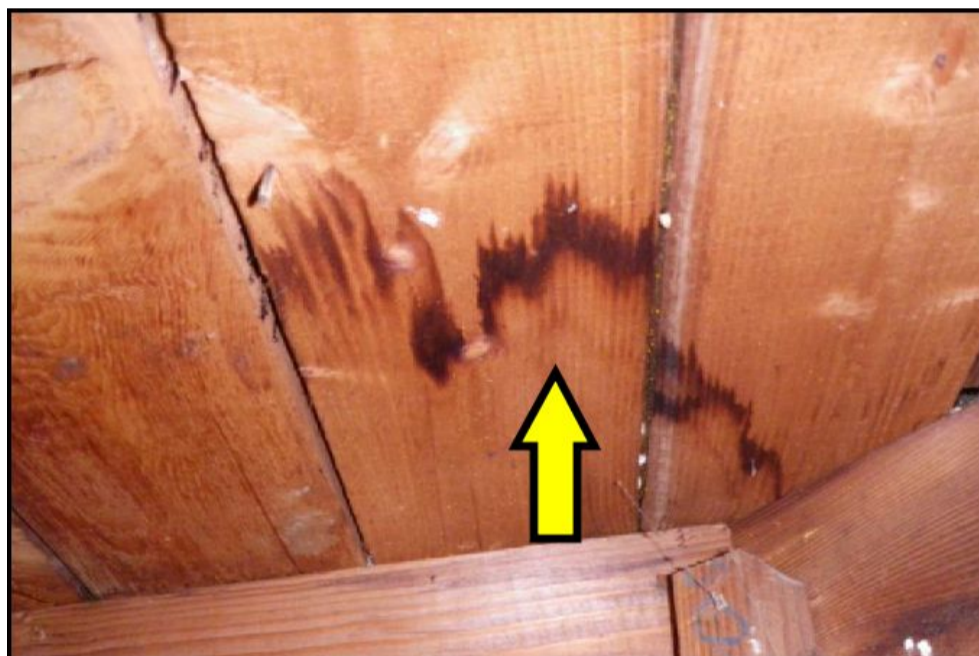
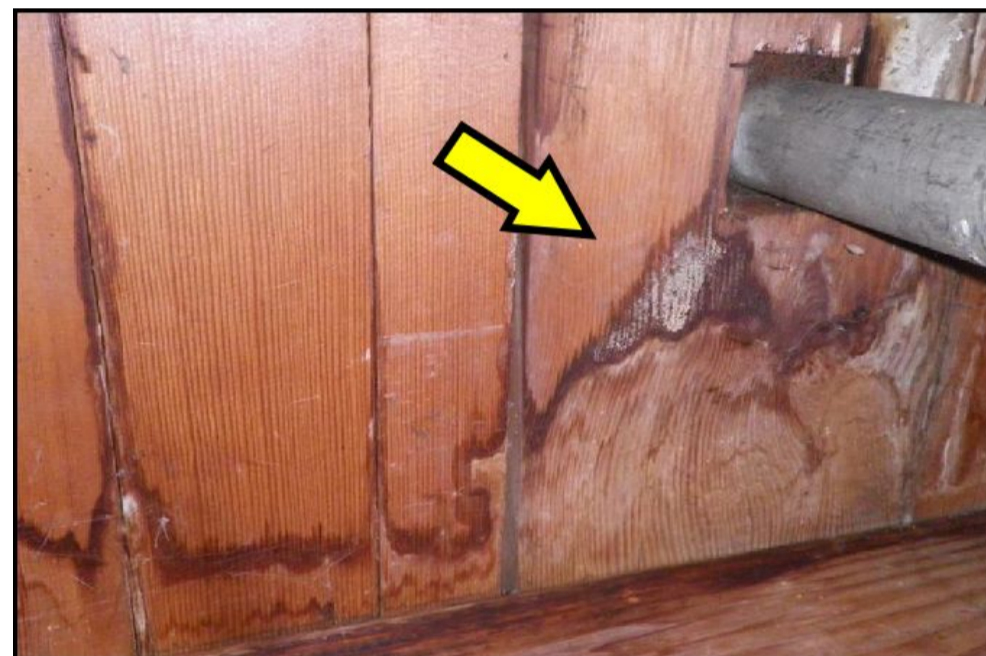
NEEDS ATTENTION 5.2. The inspector found stains on the underside of the garage roof which appear to be water related. A roofing contractor's further evaluation is recommended should you wish to rule out any existing moisture intrusion issues.

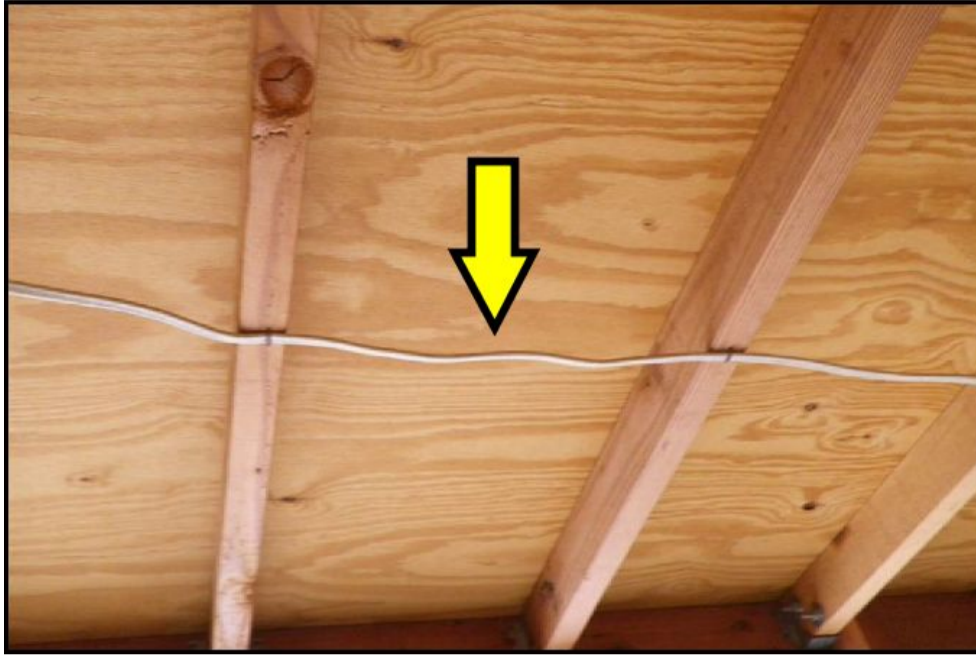
NEEDS ATTENTION 5.10. There is overhead wiring that is spanning large open spaces and/or is not properly secured to framing components. Proper securing of wiring is necessary to keep it from being snagged and pulled by yard tools or sports equipment in the garage (a potential safety hazard).
