PROPERTY INSPECTION REPORT

For The Property Located At
1035 Presidio Drive, San Diego, California 92131

Property Address:	1035 Presidio Drive
Property City:	San Diego
Property State:	California

Inspection Date:	04.02.2018
Inspection Start Time:	09:00:00 AM
Inspection End Time:	12:00:00 PM
Inspection Weather:	Clear and Dry
Inspection Temperature:	75 degrees

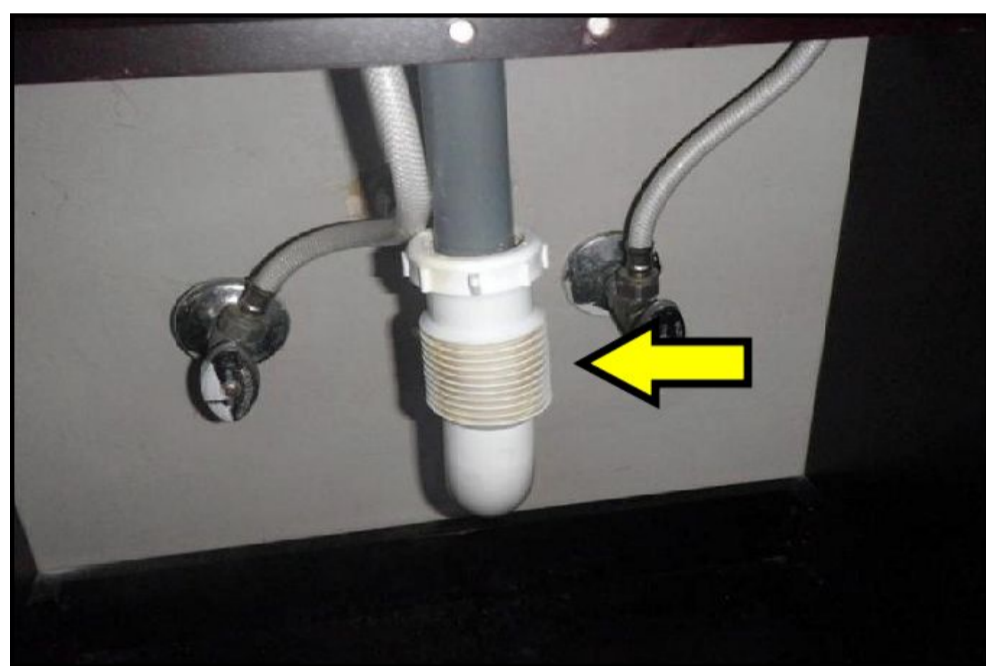
NEEDS ATTENTION 6.2. The drain line and trap under the Laundry sink is an incorrect corrugated plastic type that should be replaced with a smooth bore drain pipe to help prevent blockage.

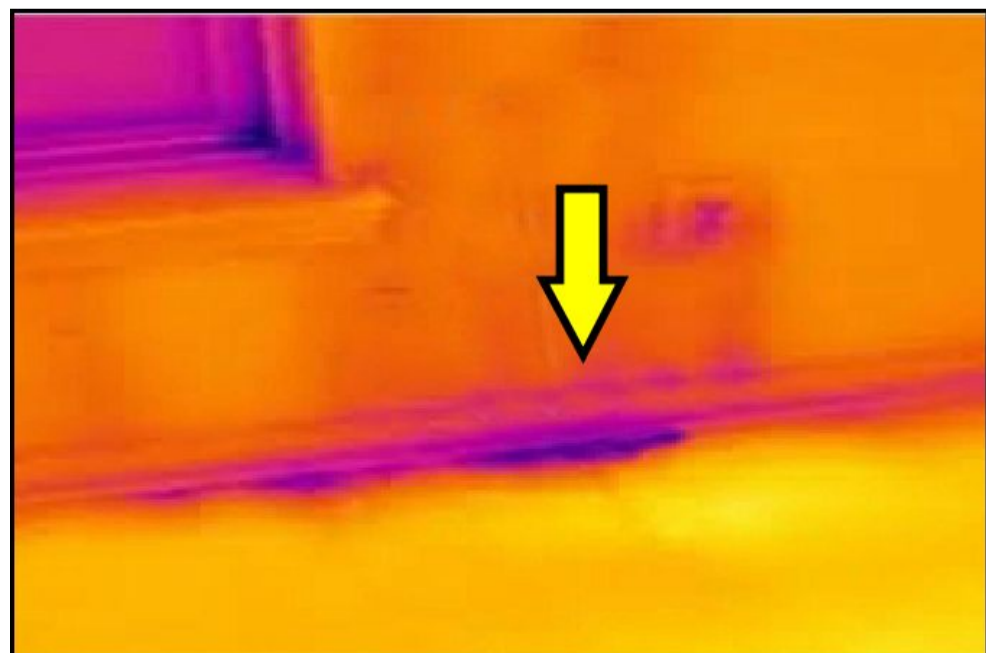
NEEDS ATTENTION 6.5. There is an area of the Laundry area floor that displays an unusual temperature difference in the viewfinder of the inspector's infrared camera (also known as a Thermal Imaging Camera). These cameras are able to detect areas where the surface temperature is unusually cooler than the surrounding surfaces. One possible cause of this cooler temperature is the presence of moisture behind the surface which infrared cameras are designed to be highly sensitive to. While the inspector cannot be 100% sure that moisture is the cause of this temperature anomaly, we recommend you have this condition further evaluated (e.g. have a contractor probe this location with a moisture meter).

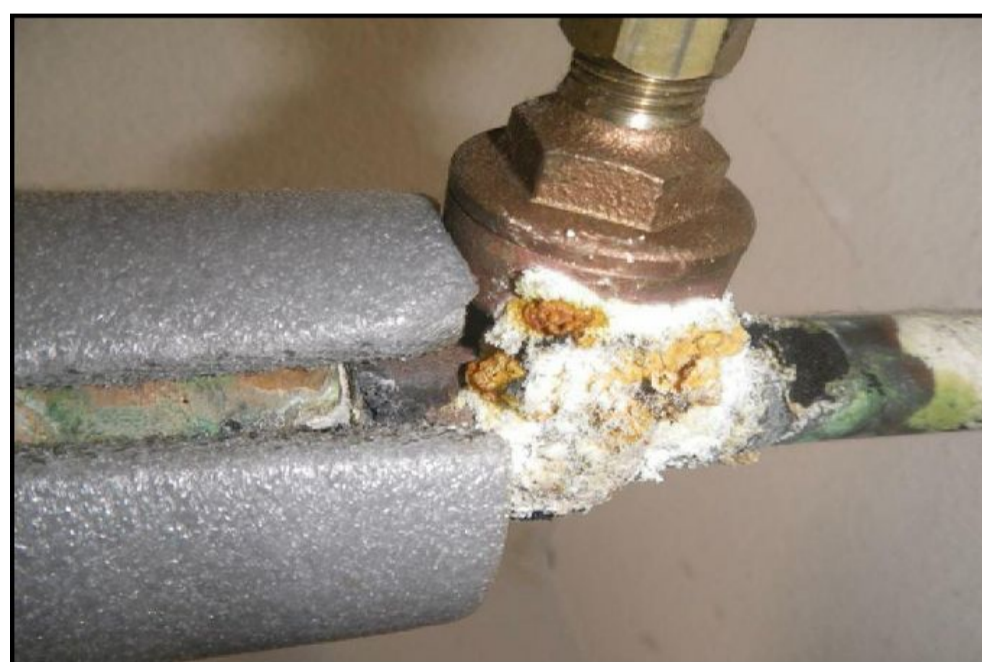
NEEDS ATTENTION 7.7. The inspector found corrosion at one or both of the water supply fittings of the water heater tank, which may indicate prior leakage (and/or which may become the site of subsequent leakage at these fittings).

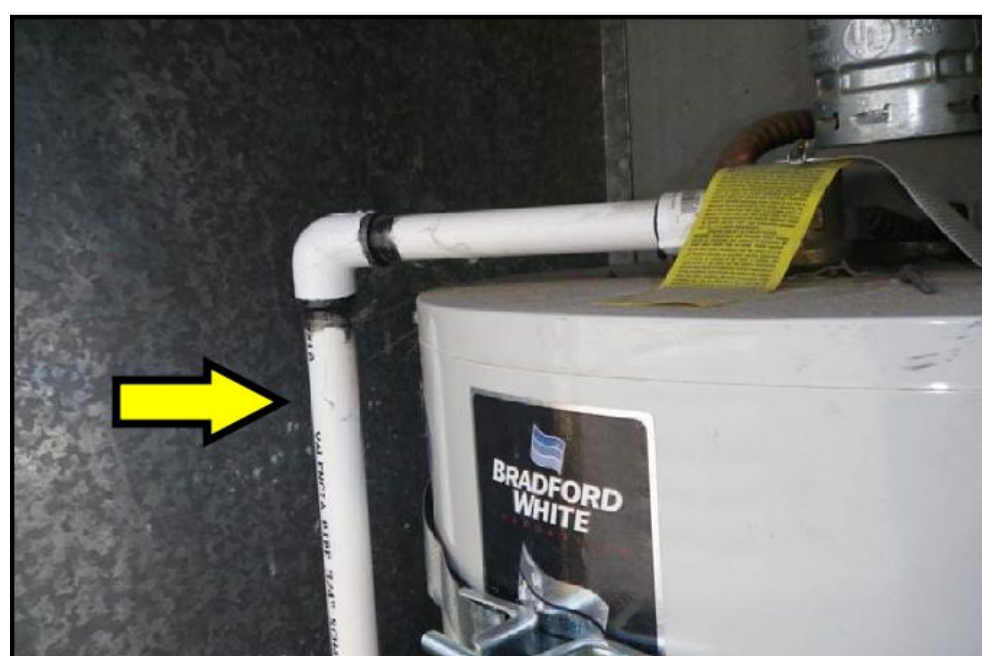
NEEDS ATTENTION 7.8. The drain line from the temperature and pressure relief valve is improper (is made of pvc pipe). For safety reasons, it should be replaced with a minimum 3/4" copper pipe.

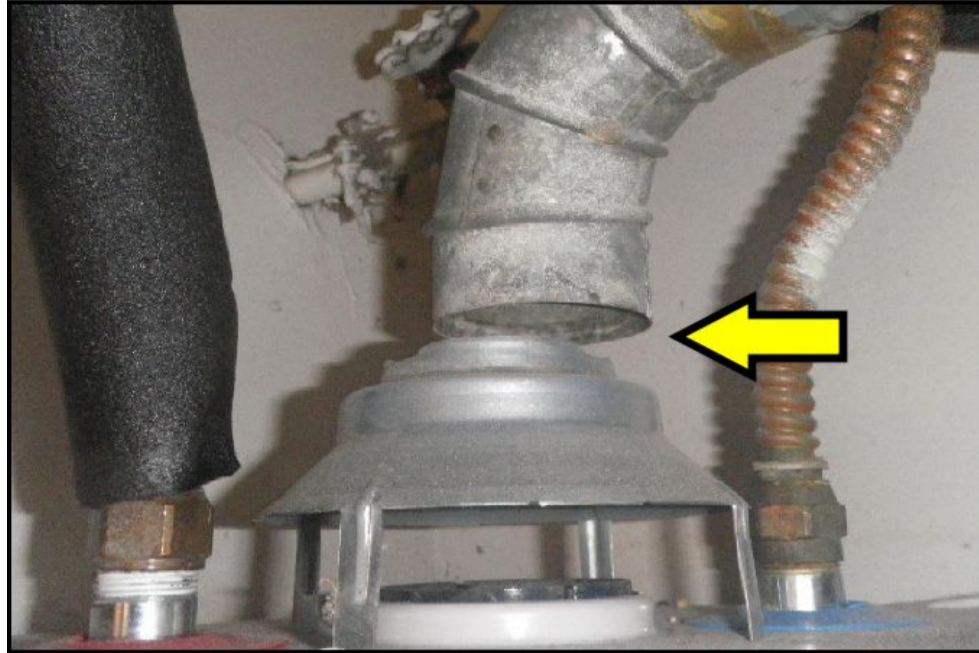
NEEDS ATTENTION 7.9. The water heater exhaust vent pipe is not securely fastened or supported, a condition that could hinder or preclude the proper venting of water heater exhaust fumes. Description: Poor connection between W.H. vent hood and vent pipe.

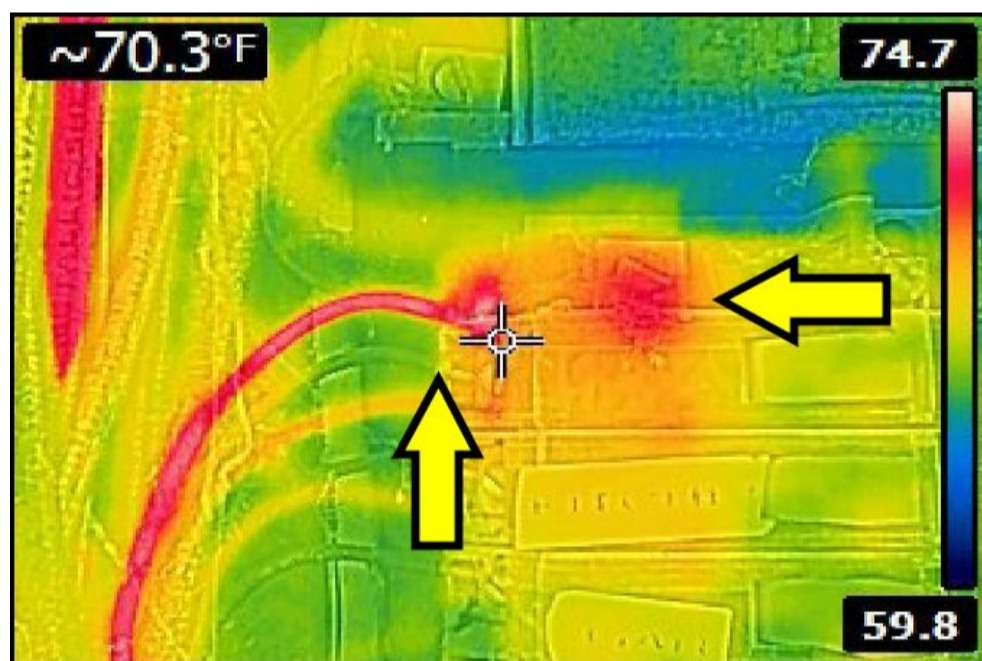
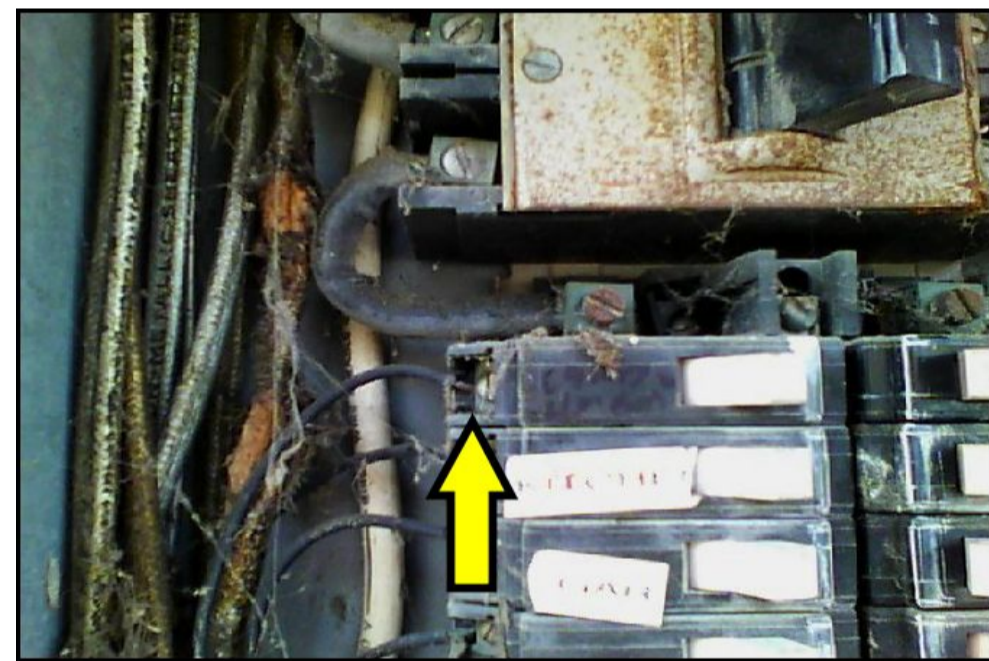
NEEDS ATTENTION 8.4. There is a circuit breaker in the electrical panel displaying an unusual temperature difference in the viewfinder of the inspector's infrared camera (also known as a Thermal Imaging Camera). These cameras are able to detect areas where the surface temperature is unusually hotter than the surrounding breakers. One possible cause of this hotter temperature is defective wiring and/or a malfunctioning or improper circuit breaker. While the inspector cannot be 100% sure that this temperature anomaly is the result of a panel deficiency, we recommend an electrician further evaluate the panel to rule out a potential electrical fire or safety hazard.

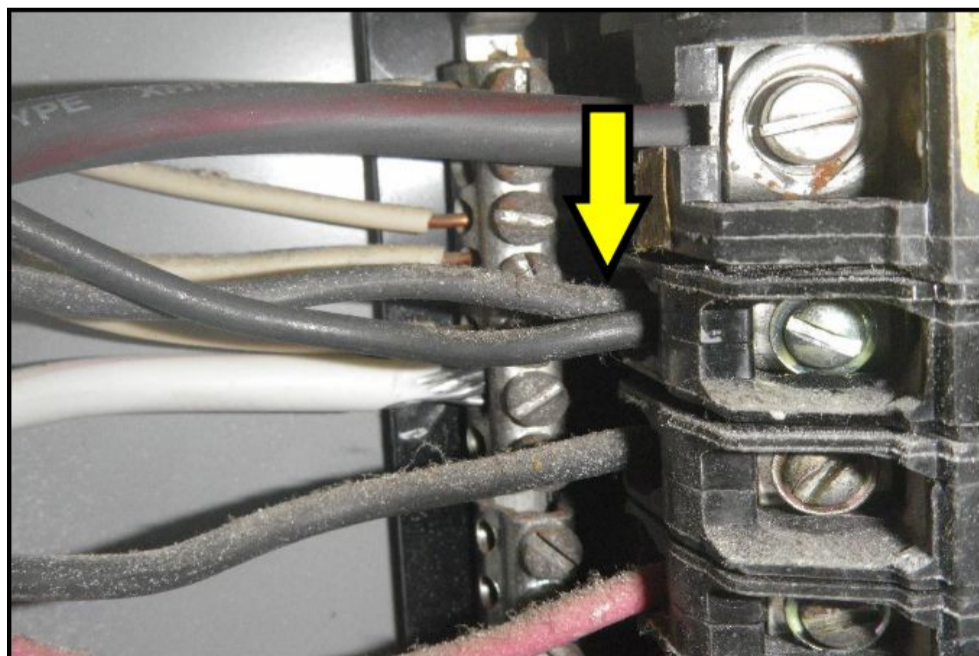
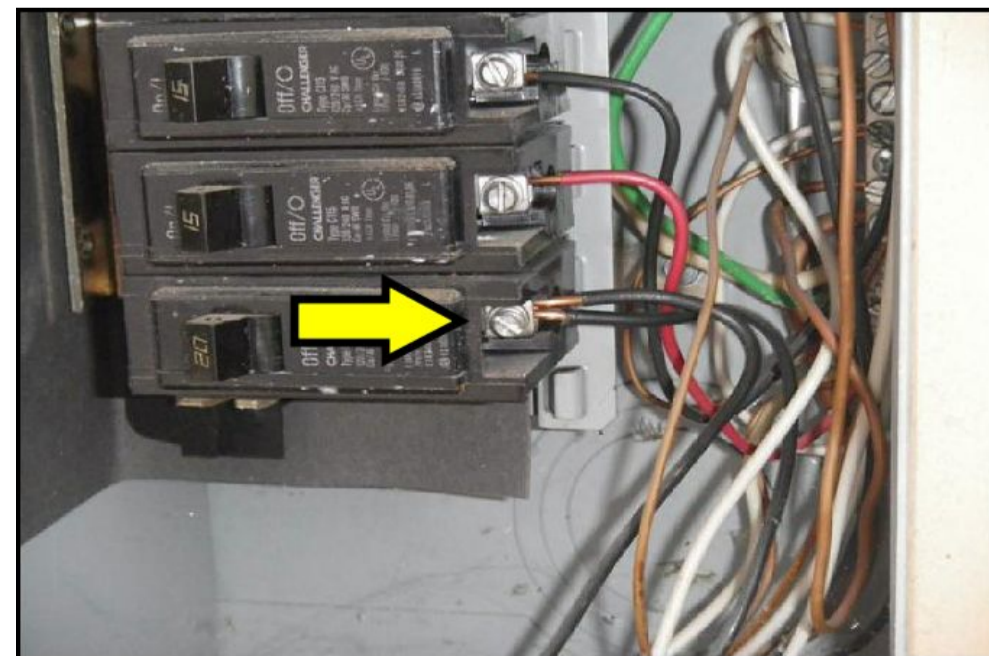
NEEDS ATTENTION 8.6. One or more of the circuit breakers in the main panel has doubled up wiring to it. This creates a potential fire hazard that should be corrected.

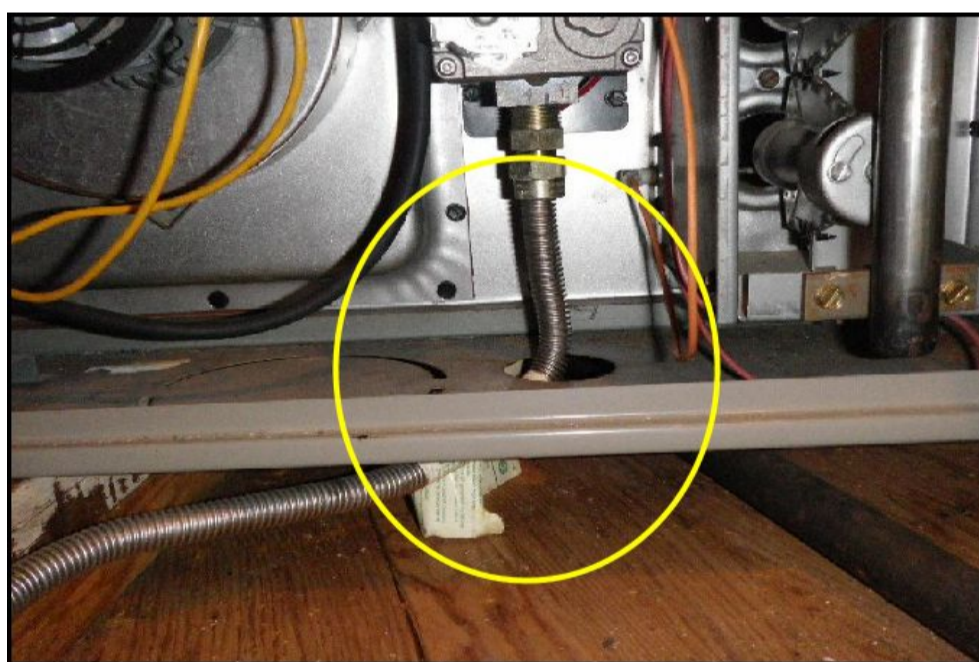
NEEDS ATTENTION 9.3. The use of a flexible gas line is improper and will need to be replaced with rigid black pipe.

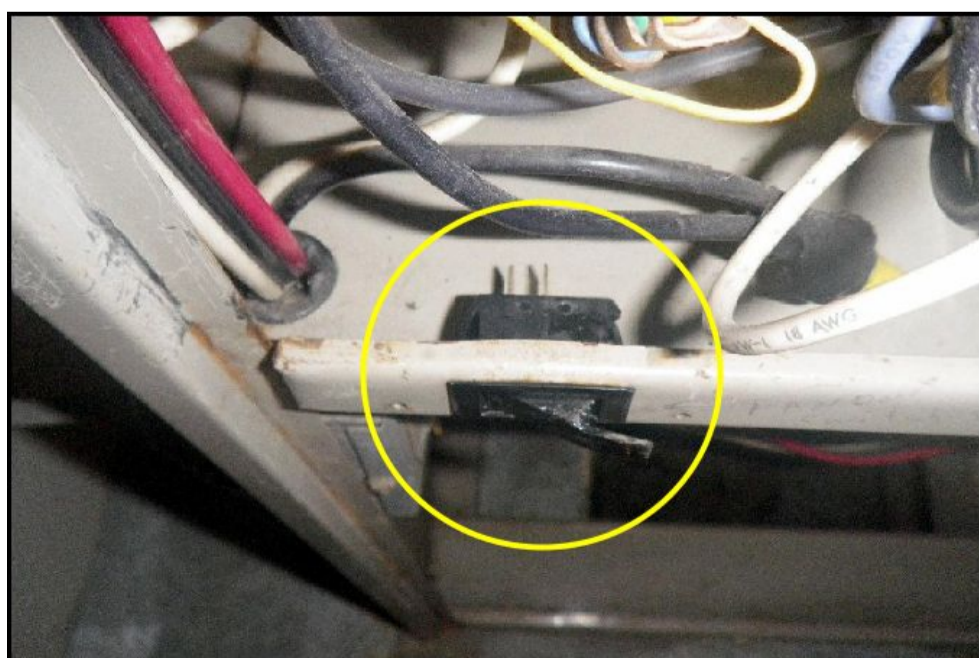
NEEDS ATTENTION 9.4. The heating unit (FAU) has a faulty access panel door safety switch (disconnected). This furnace door switch prevents the fan and burner from coming on while the access panel is removed. We recommend further evaluation of the unit by an HVAC technician for repair options and costs.

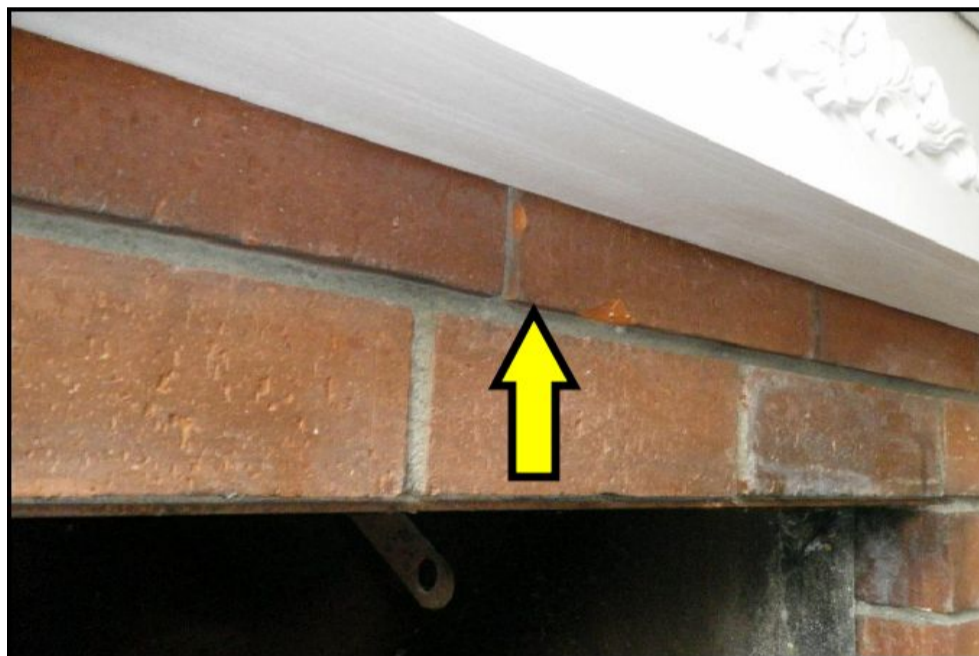
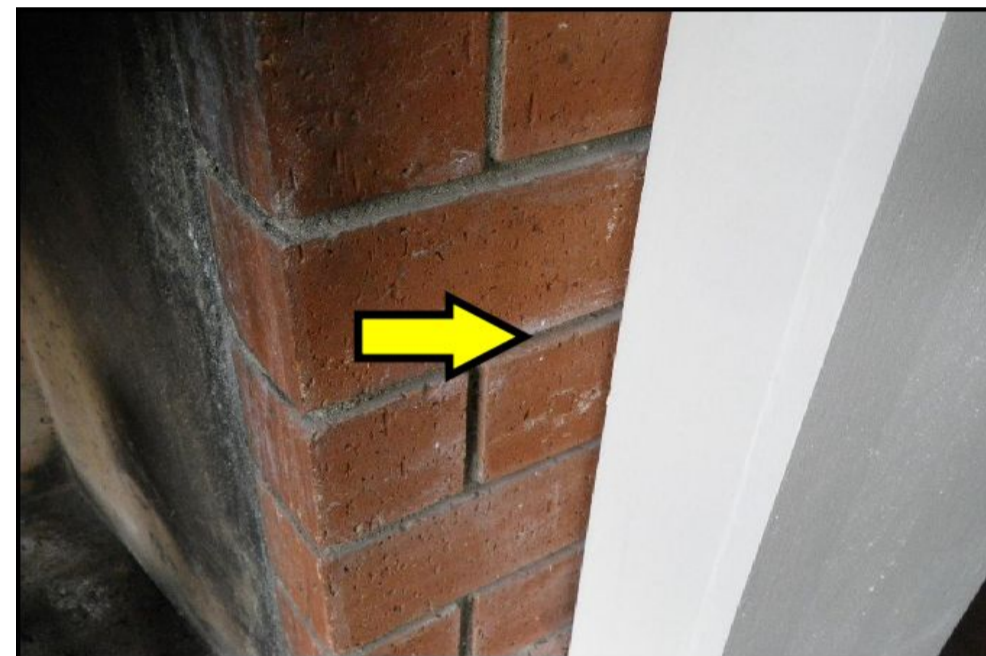
NEEDS ATTENTION 10.1. The required clearance from the opening of the fireplace to the wood frame and mantel is not met. Without the necessary clearances, heat can transfer through the fireplace to the wood frame and mantel. This is considered a potential fire hazard and we recommend you have this condition corrected.

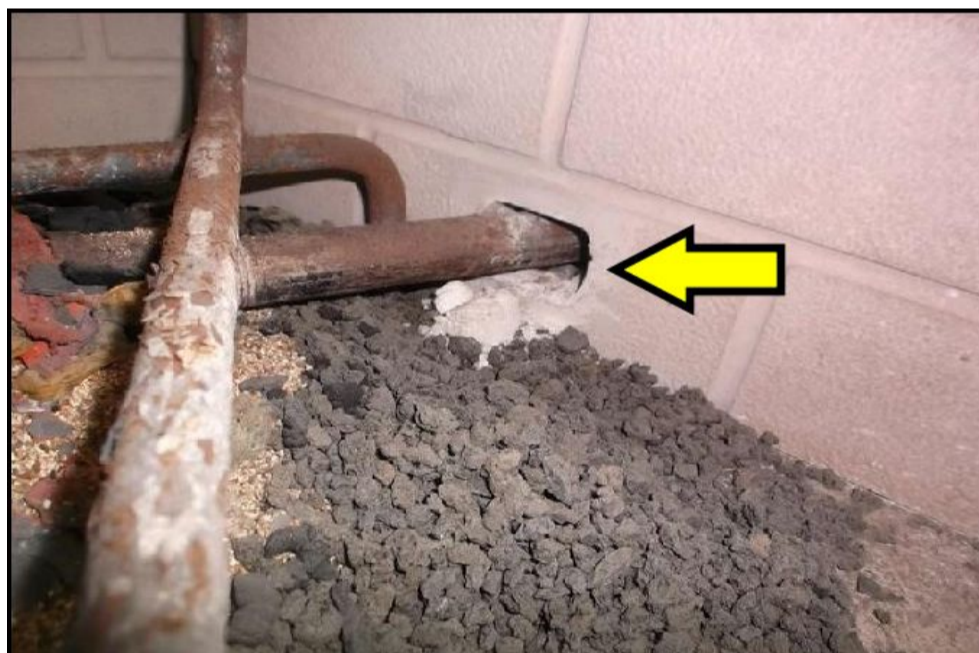
NEEDS ATTENTION 10.2. There is a gap around the hole where the gas supply pipe enters into the interior of the firebox. This gap should be sealed to prevent the passage of heated gases through this gap.

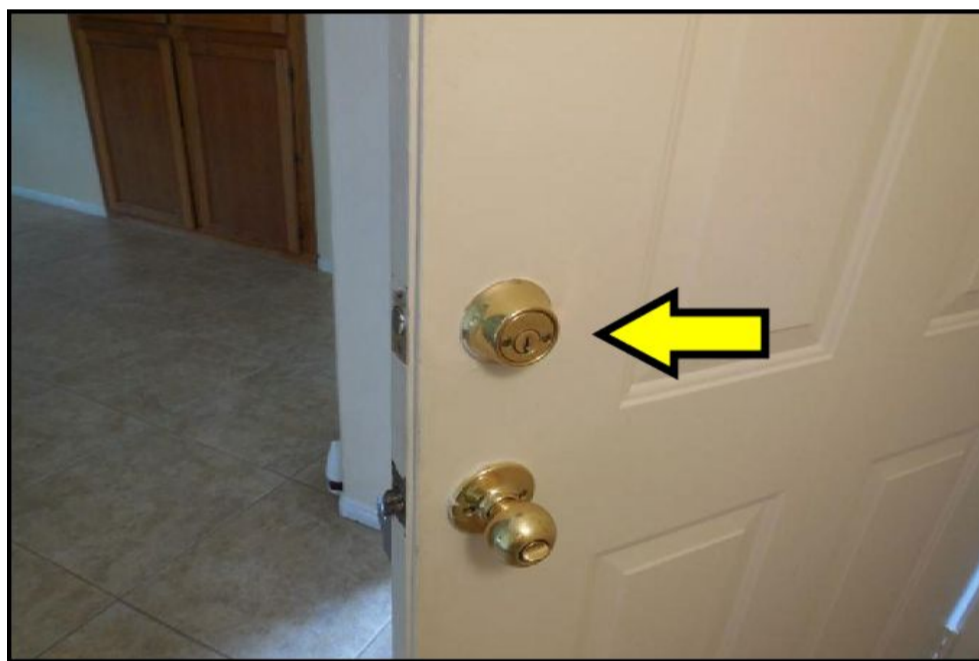
NEEDS ATTENTION 11.2. The door's deadbolt is keyed on the interior side of the door instead of having a non-keyed latch to open the door. This is a potential safety hazard during a fire should occupants be unable to exit the residence because the key is not in the deadbolt.

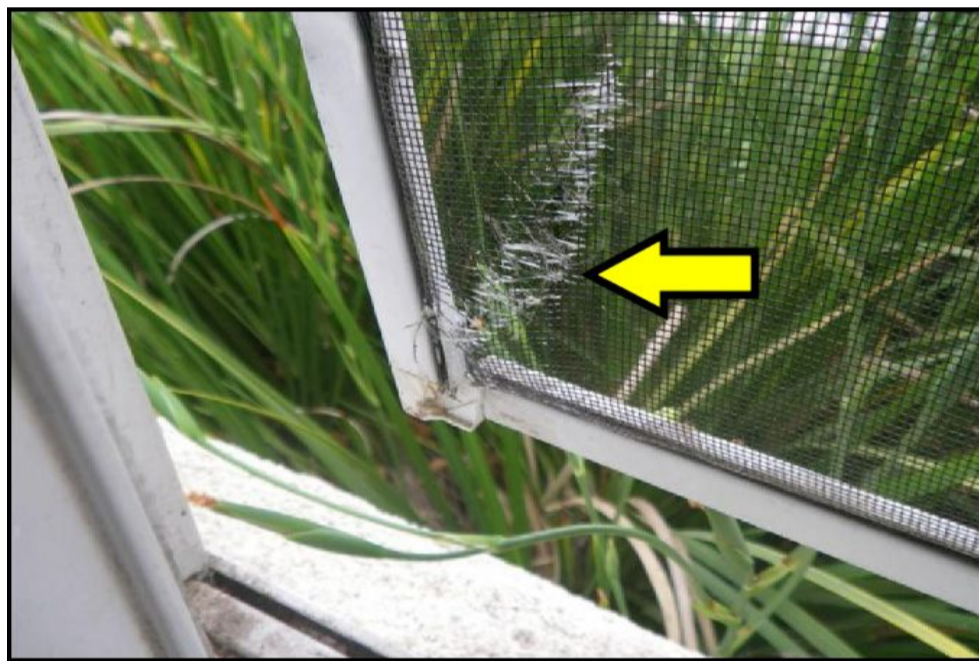
NEEDS ATTENTION 11.9. Damage to the screen for the window(s) of this room was observed (i.e. ripped and/or holes).

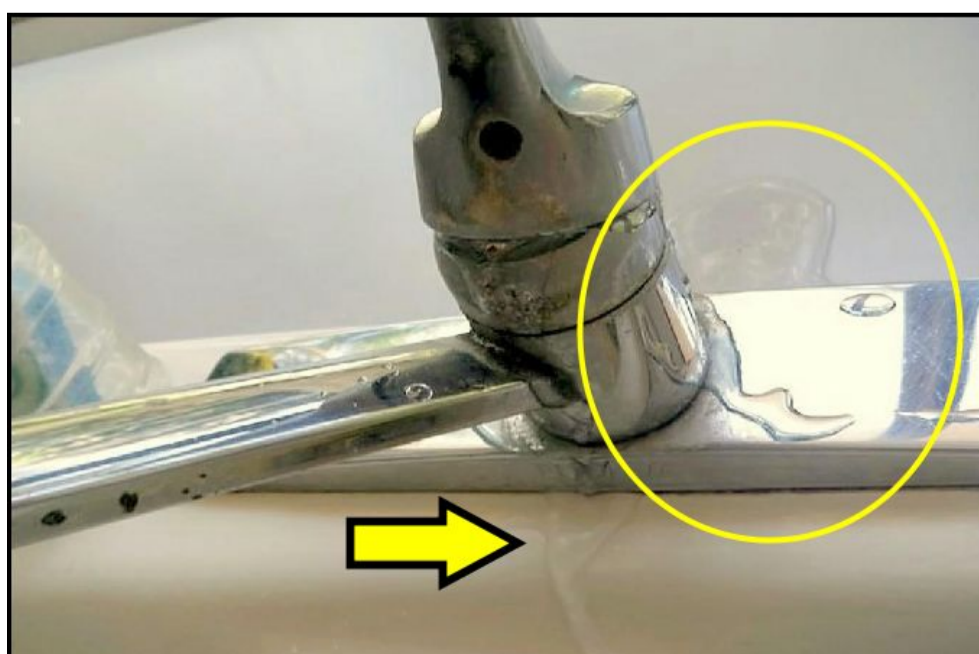
NEEDS ATTENTION 11.12. The sink faucet was observed to be leaking. around the faucet swivel arm as well as under the base plate.

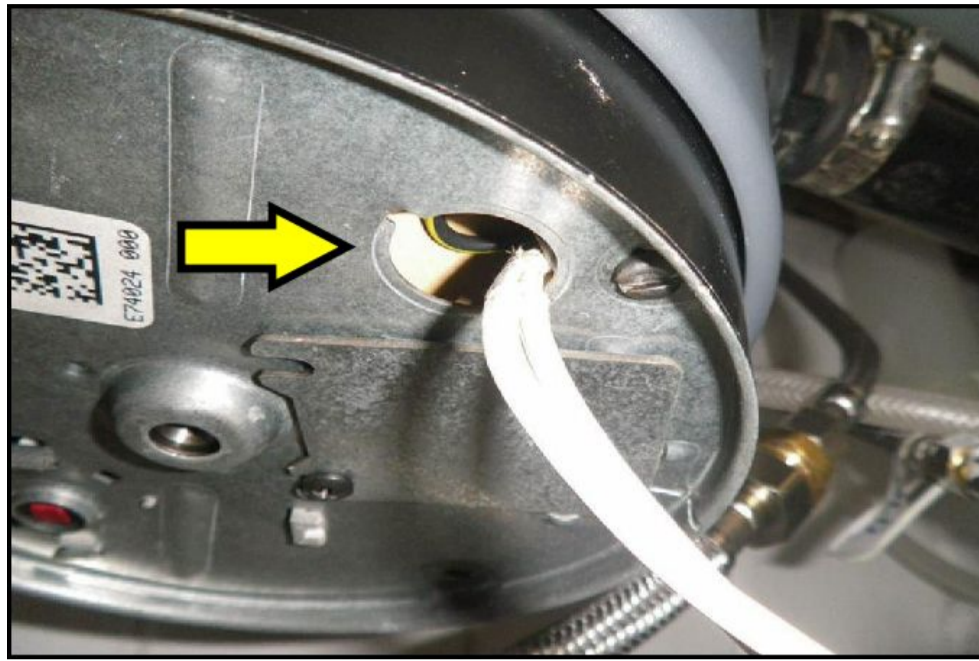
NEEDS ATTENTION 11.13. The garbage disposal is improperly wired in that there is no bushing or clamp installed where the electrical line enters the garbage disposal.

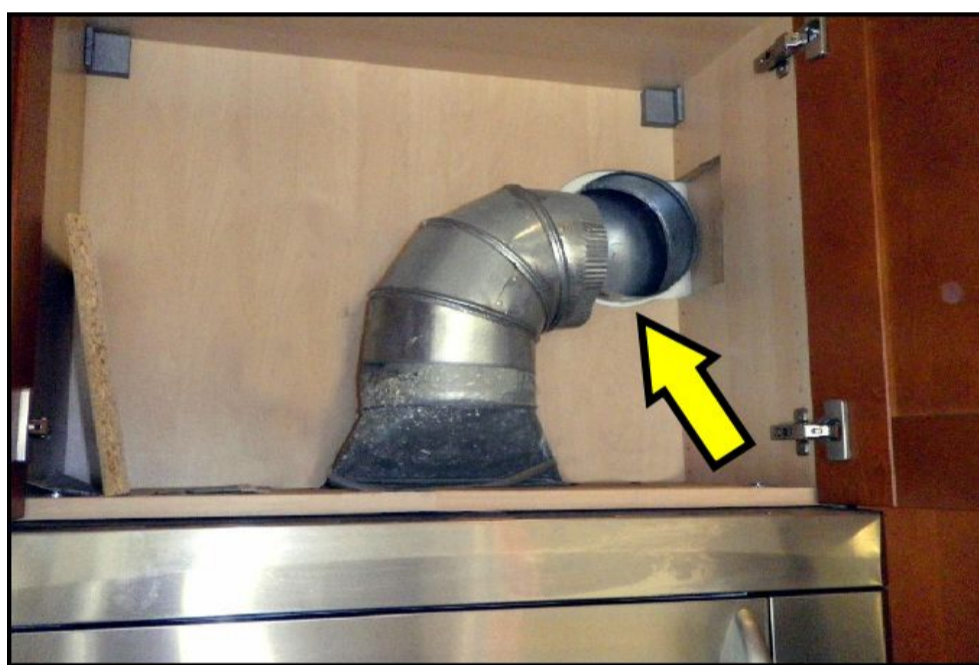
NEEDS ATTENTION 11.14. The hood's exhaust/vent pipe is not connected. We recommend correction of this to ensure proper venting of the stove top/range.

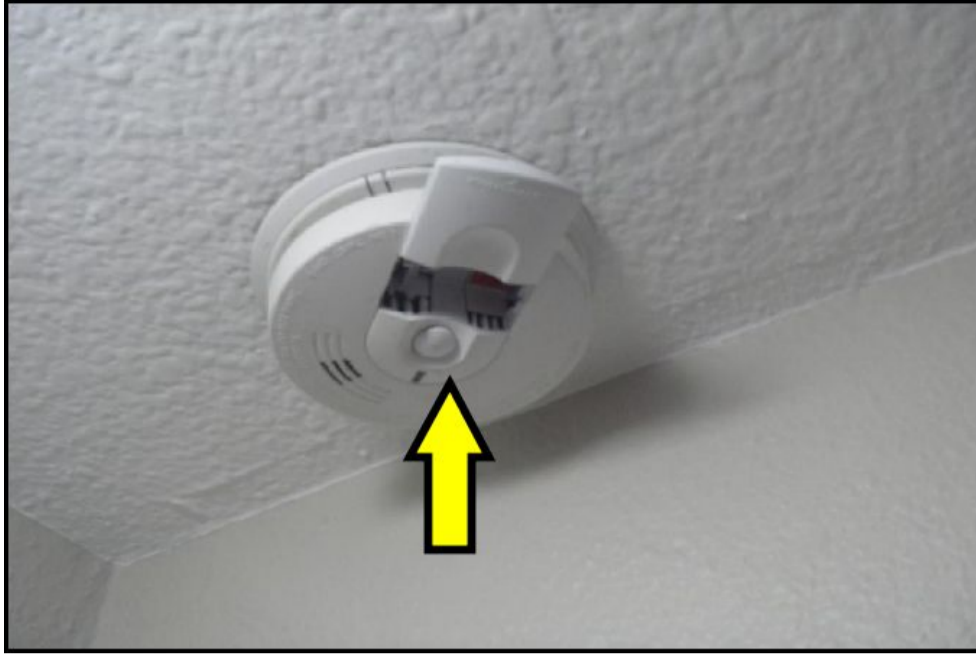
NEEDS ATTENTION 11.20. The smoke detector was missing a battery.

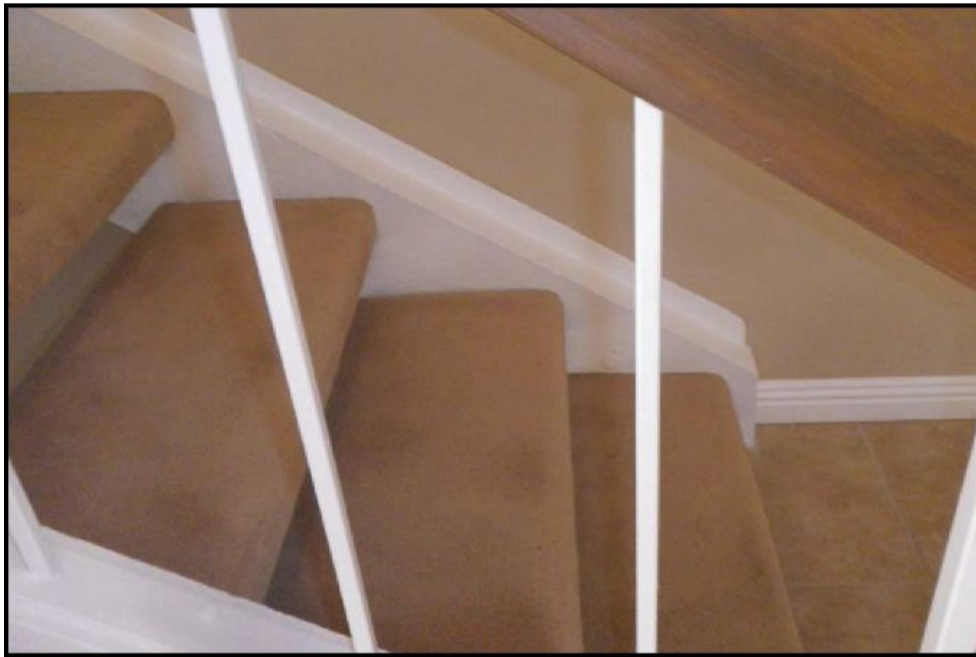
NEEDS ATTENTION 11.21. The balusters in the stair guardrail are more than four inches apart and are not child safe. Although it may not have been a requirement at the time of construction, consideration should be given to a reduction in the width of these openings.

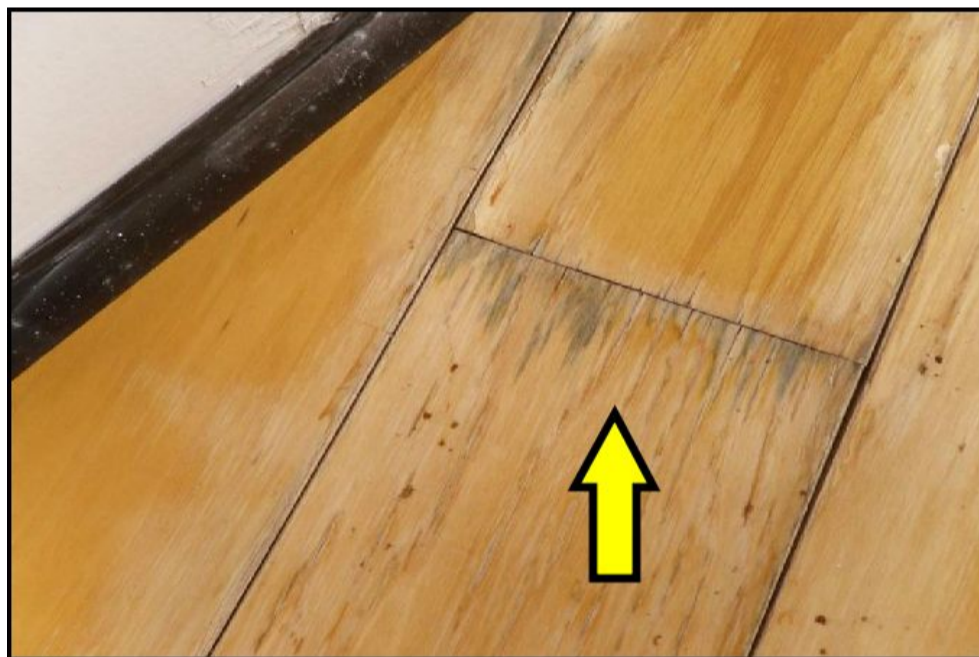
NEEDS ATTENTION 12.3. A portion of the flooring was found to be water stained, indicating an existing or a previously repaired moisture intrusion problem. Further evaluation is recommended to determine the cause of this water staining.

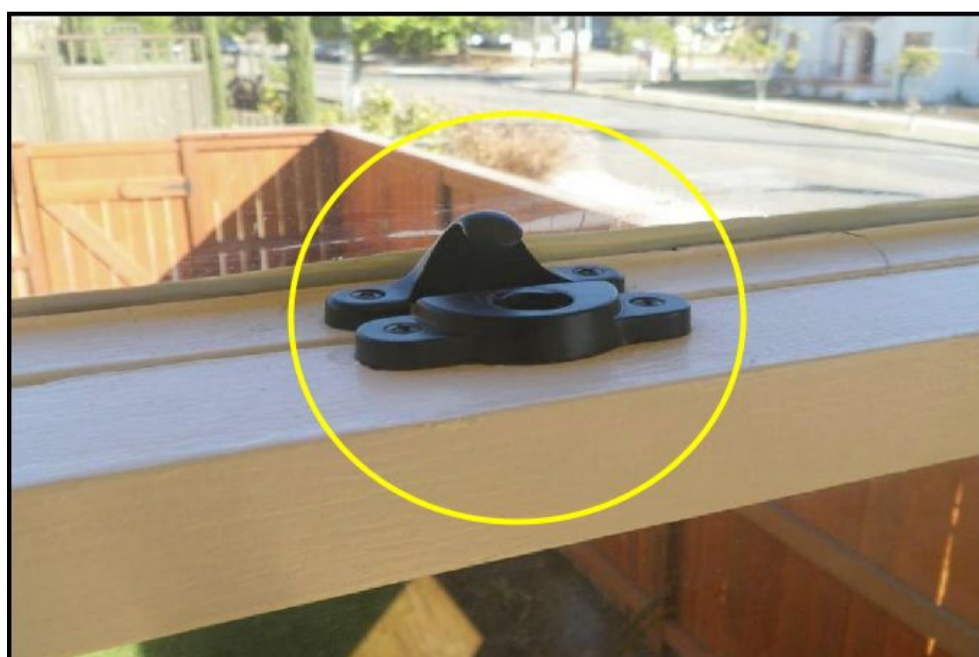
NEEDS ATTENTION 12.4. The latching or locking hardware is missing for the window(s) of this room. Deficiency: window crank(s) missing.

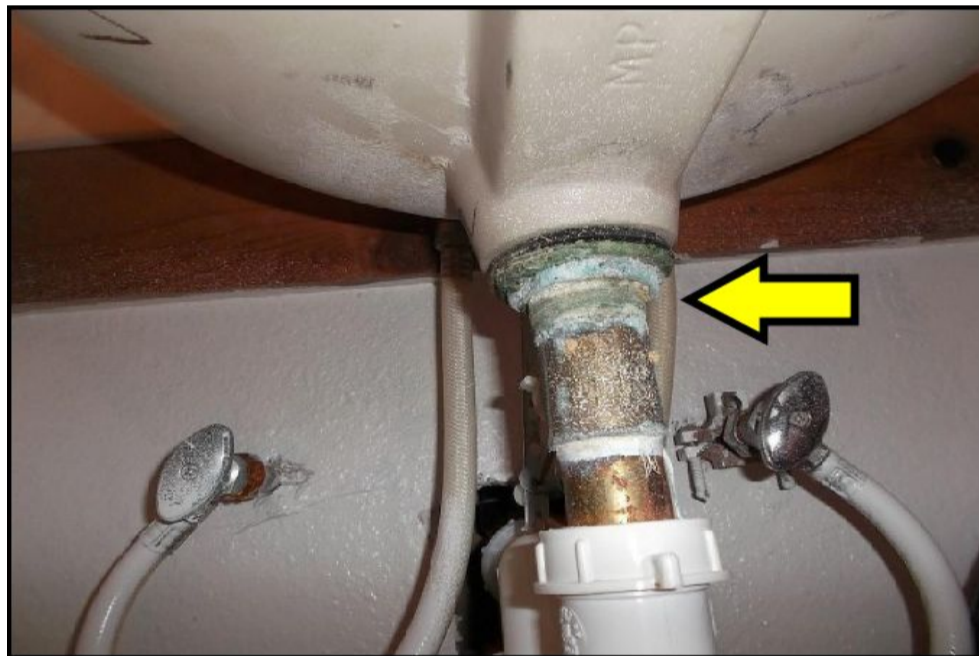
NEEDS ATTENTION 14.2. Corrosion was found at the water supply line(s) under the sink. Left uncorrected, these lines may eventually leak and lead to moisture intrusion problems (e.g., wood damage, mold).
