HOME INSPECTION REPORT

For The Property Located At
4766 Dovetail Drive, Oceanside, CA 92054

Property Address:	4766 Dovetail Drive
Property City:	Oceanside
Property State:	CA

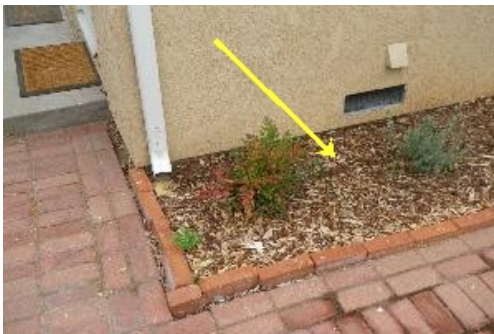
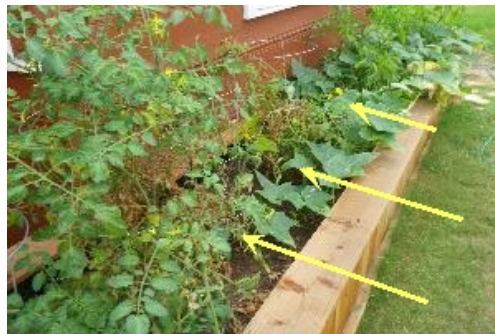
1.9 - DEFICIENT: There are one or more planters (either above grade or at grade level) that are located adjacent to the structure. These planters often trap and pond water which can cause moisture intrusion, mold growth, damage to the foundation and/or settlement. Note: your inspector is unable to inspect for possible water damage to any visually inaccessible areas of the structure in the vicinity of these planters.

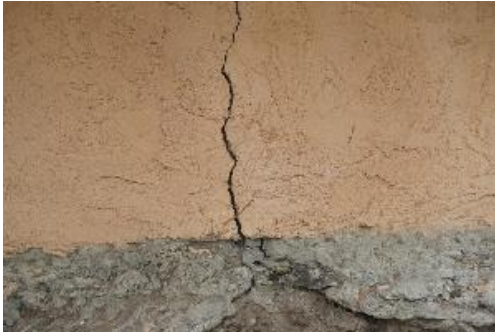
1.11 - DEFICIENT: There are cracks in the stucco finish that are up to 1/8" in width . Although stucco cracking of this nature may be the result of benign conditions (poor construction, age, minor settlement), the limited scope of a home inspection precludes the inspector from being able to definitively rule other causes of a potentially serious nature (e.g., unstable or expansive soils adversely impacting the structure). Location: Right side.

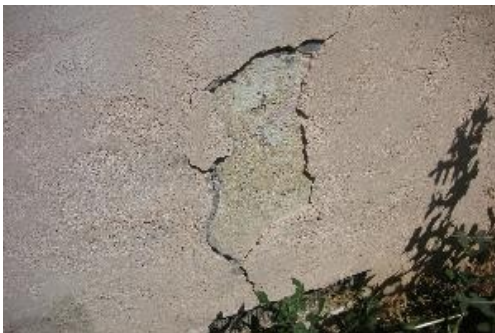
1.12 - DEFICIENT: The stucco of one or more of the exterior walls of the structure has damage and needs repair. Location: Left side.

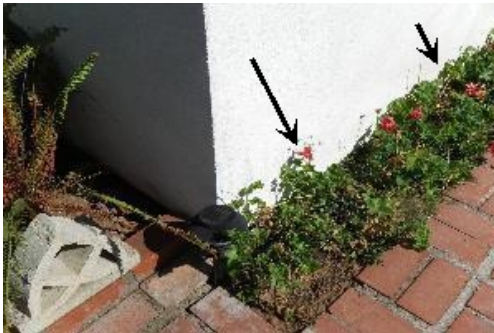
2.1 - INFORMATIONAL: There were areas of the exterior perimeter slab foundation that were visually inaccessible. Inaccessible area: the left side of the garage. The inspector's view of the slab/stem wall edge was blocked or obscured by vegetation and stucco extending over slab edge. While the inspector will note slab deficiencies that are visually accessible to him, reporting of slab deficiencies that may be spotted in the inaccessible areas is beyond the scope of this inspection. We recommend reinspection of the perimeter slab foundation after removal of the obstruction.

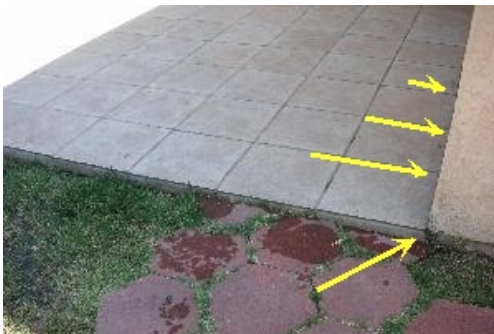
2.2 - DEFICIENT: The inspector found that the poured concrete around the base of the exterior walls came within 2" of the weep screed. The weep screed is a built-in horizontal metal flashing along the base of the exterior stucco wall that impedes moisture from accumulating and reaching to the inside of the wall (needs to be a min. 2" clearance from weep screed to concrete/base of wall). Although inspectors routinely come across this deficiency, it can contribute to moisture buildup in and around the foundation.

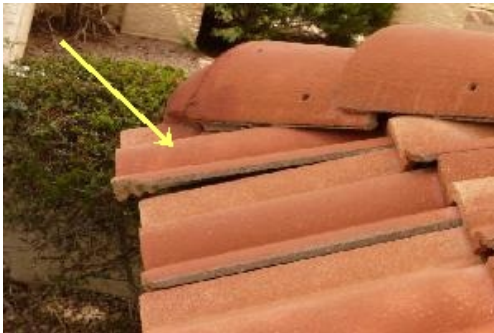
3.4 - DEFICIENT: The roof of the residence has a loose and slipped clay tile which is likely to increase the roof's susceptibility to leaks. The slipped tile replacement is recommended. Location: Front side, lower row.

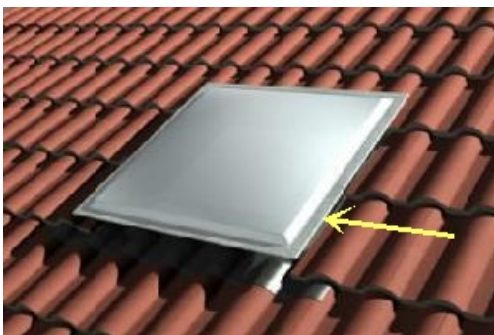
3.6 - DEFICIENT: There is a broken hermetic seal at the dual-glazed skylight, as is evident from the condensation forming between the layers of glass.

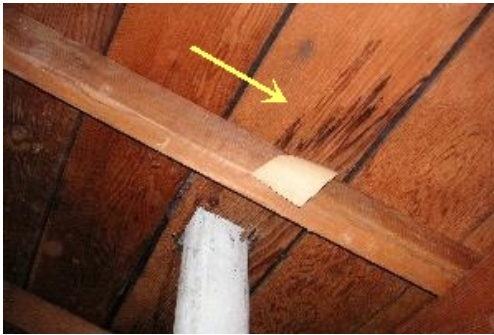
4.1 - DEFICIENT: There are moisture stains and/or sufficient evidence of prior roof leakage on the underside of the roof . Location: Lower left side of attic. This water stain appears to be in the location of the loose/slipped tile noted in the roof section.

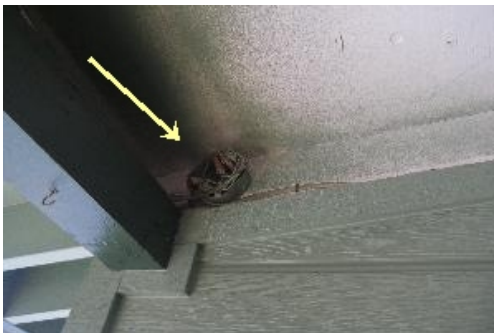
5.9 - DEFICIENT: There are one or more open electrical junction boxes in the garage that should be sealed so as to keep any arcing or sparking contained within the box.

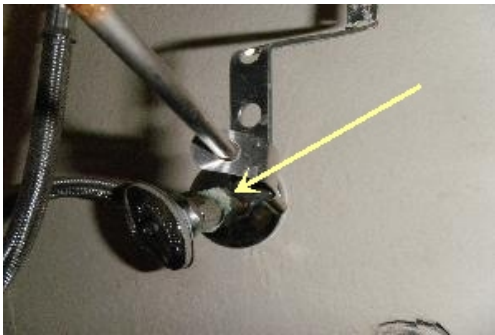
6.2 - DEFICIENT: The hot water supply valve under the sink is corroded and should be serviced.

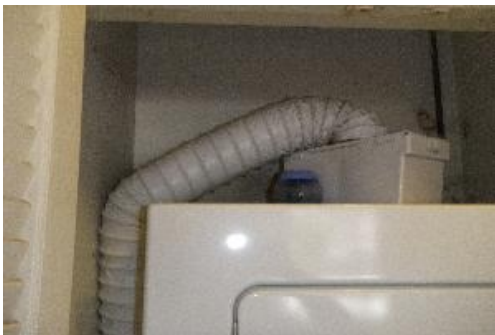
6.4 - DEFICIENT: The clothes dryer vents incorrectly into a canister instead of venting to the exterior. We recommend that a solid metal vent be installed and routed to an appropriate exterior location and equipped with a backdraft damper.

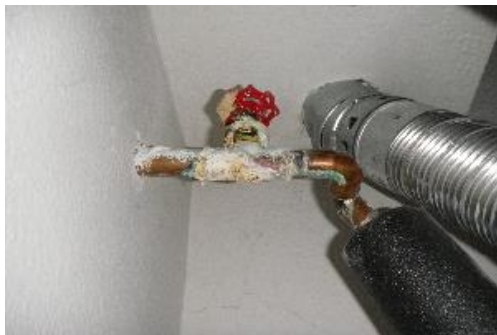
7.4 - DEFICIENT: There is rust or corrosion at the water supply fittings of the water heater and/or the cold water valve itself.

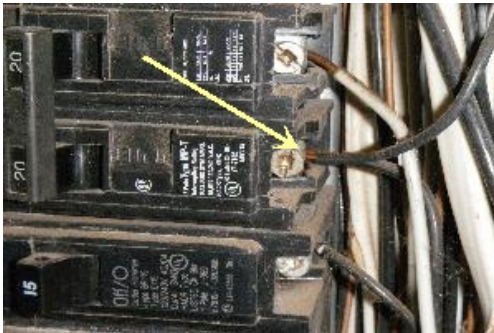
8.4 - DEFICIENT: One or more of the circuit breakers in the main panel has doubled up wiring to it. This creates a potential fire hazard that should be corrected.

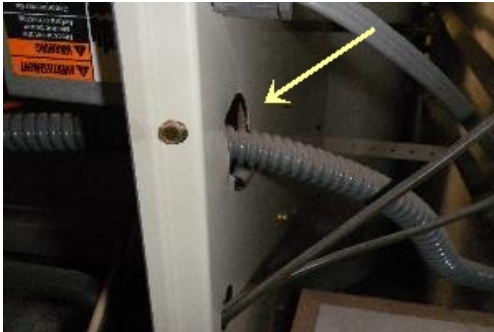
9.3 - DEFICIENT: The use of a flexible gas line is improper and will need to be replaced with rigid black pipe. Deficiency: Flexible line enters into unit.

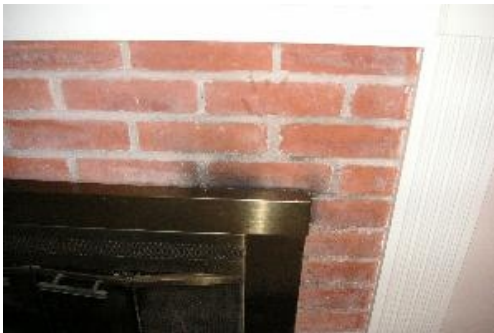
10.4 - DEFICIENT: The fireplace appears to have a drafting problem, as indicated by the dark staining above the fireplace opening. The exact cause of this condition is unknown but may be due to an undersized flue, defective construction and/or improper use of the damper.

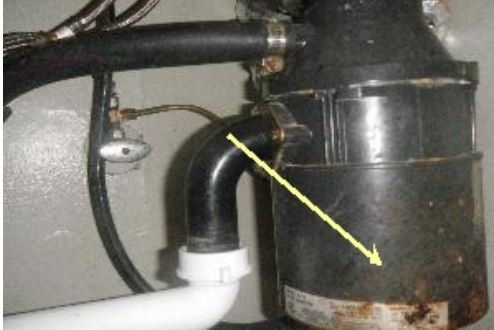
11.11 - DEFICIENT: The garbage disposal under the kitchen sink shows rust and corrosion. This may indicate that the garbage disposal is at or near the end of its useful life.

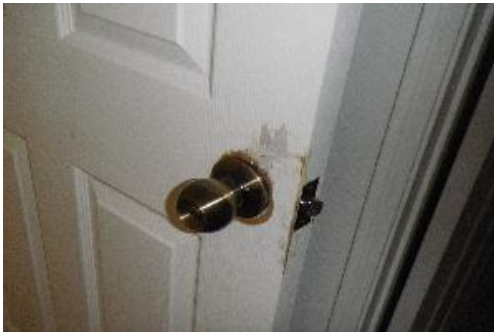
12.4 - DEFICIENT: There is damage to the bedroom door that you should be aware of and that you may wish to have repaired. Damage:

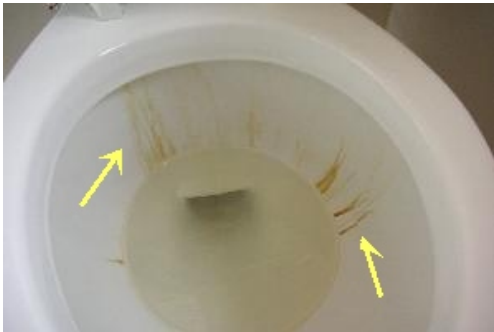
13.6 - DEFICIENT: There are rust stains in the toilet bowl that suggest an internal leak. Recommend replacement of the internal plumbing components to address this situation.

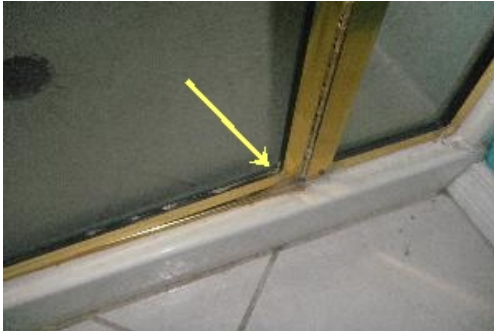
14.2 - **DEFICIENT**: There is corrosion at the tub enclosure door (and/or door track).

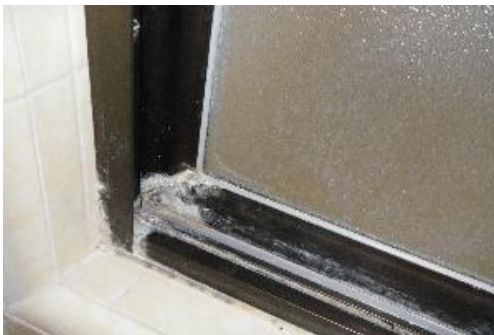
14.4 - **DEFICIENT**: The metal frame for the glass shower stall enclosure is rusting or corroded.

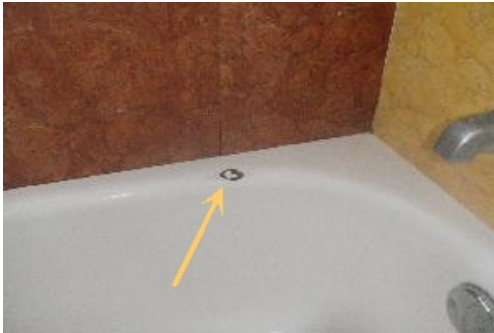
14.9 - DEFICIENT: There is a chip in the bathtub of the bedroom bath that will need to be repaired to help prevent moisture intrusion.

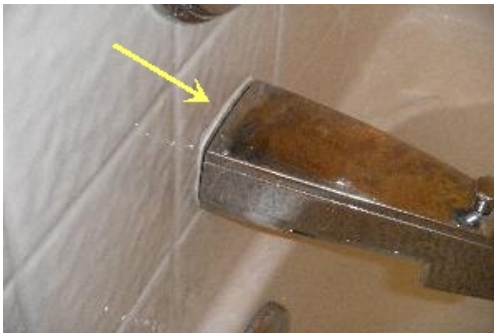
14.10 - DEFICIENT: Caulking is absent or in poor condition at the bedroom bathroom tub spout and needs attention to prevent potential (or further) water intrusion into the sub-floor and walls of the bathroom.
