PROPERTY INSPECTION REPORT

For The Property Located At
1035 Presidio Drive, San Diego, California 92131

Property Address:	1035 Presidio Drive
Property City:	San Diego
Property State:	California

Inspection Date:	04.02.2018
Inspection Start Time:	09:00:00 AM
Inspection End Time:	12:00:00 PM
Inspection Weather:	Clear and Dry
Inspection Temperature:	75 degrees

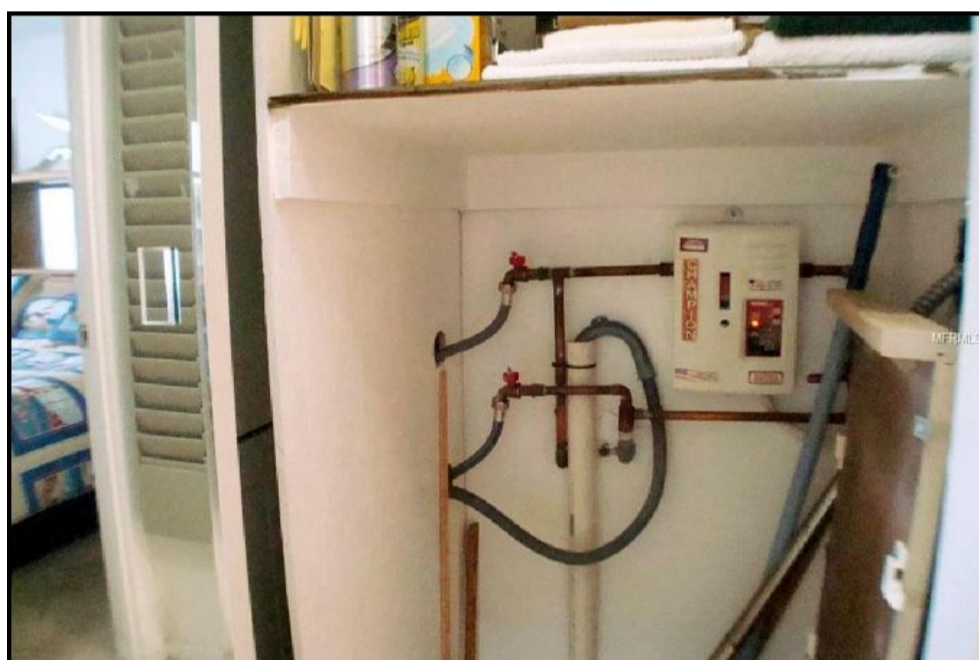
INFORMATIONAL 7.10.

There is a second, approximate 10 year old, tankless electric water heater located in the hall closet.

SATISFACTORY 7.11. This water heater was functioning satisfactorily at the time of the inspection, with no evidence of prior or active leakage observed.

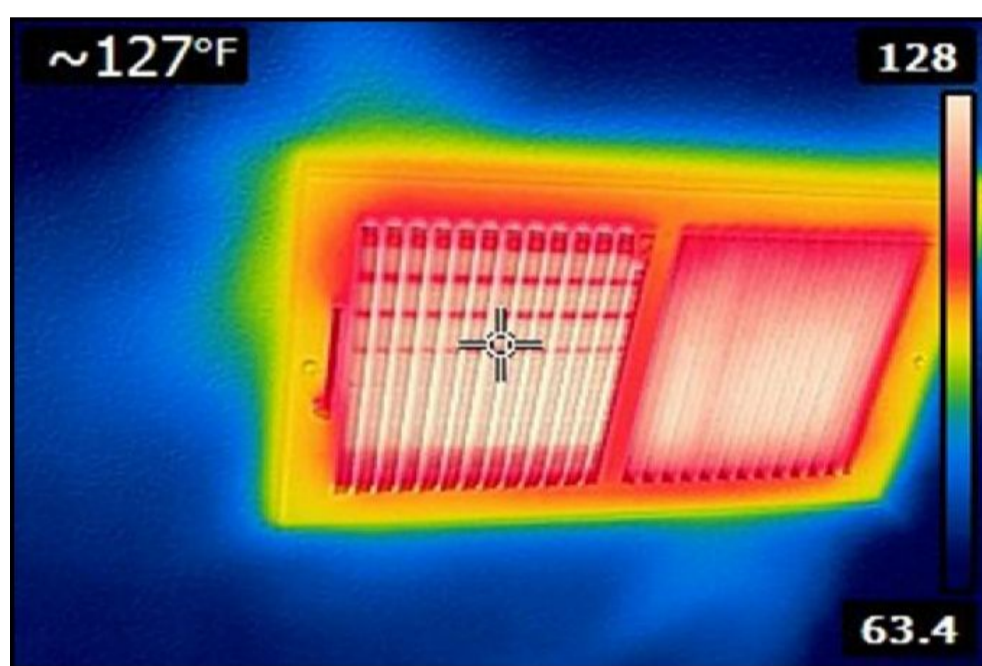
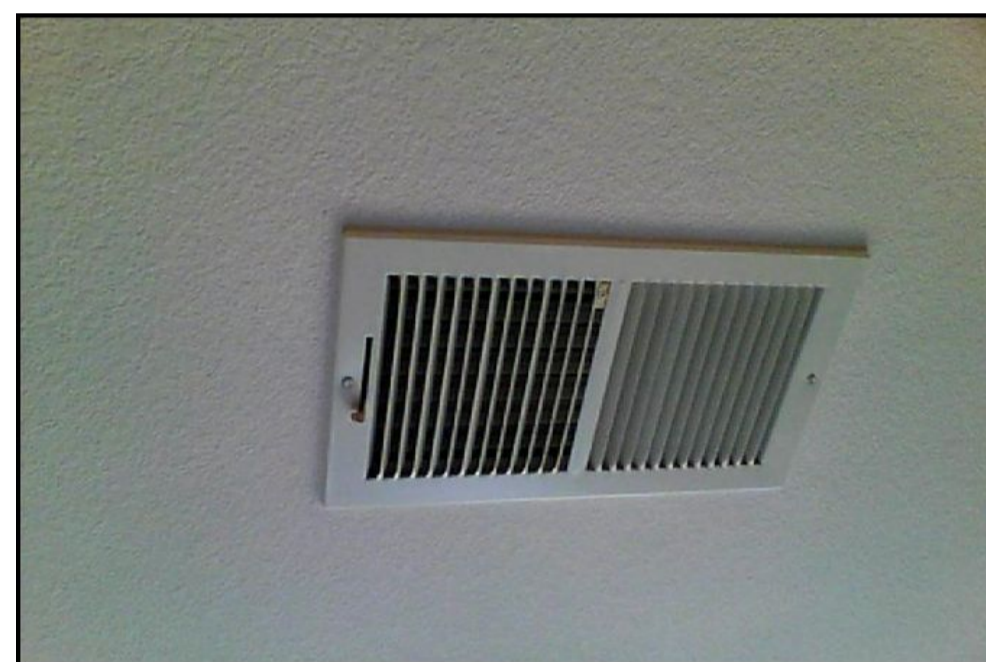
INFORMATIONAL 9.1. The structure is heated by a gas fired forced air unit (FAU). Location: the attic.

INFORMATIONAL 9.2. Using a thermal imaging camera, the following readings were taken while the heating system was in operation: Temperature at Return: 64 degrees. Temperature at Register: 127 degrees. The heater appears to be operating properly.

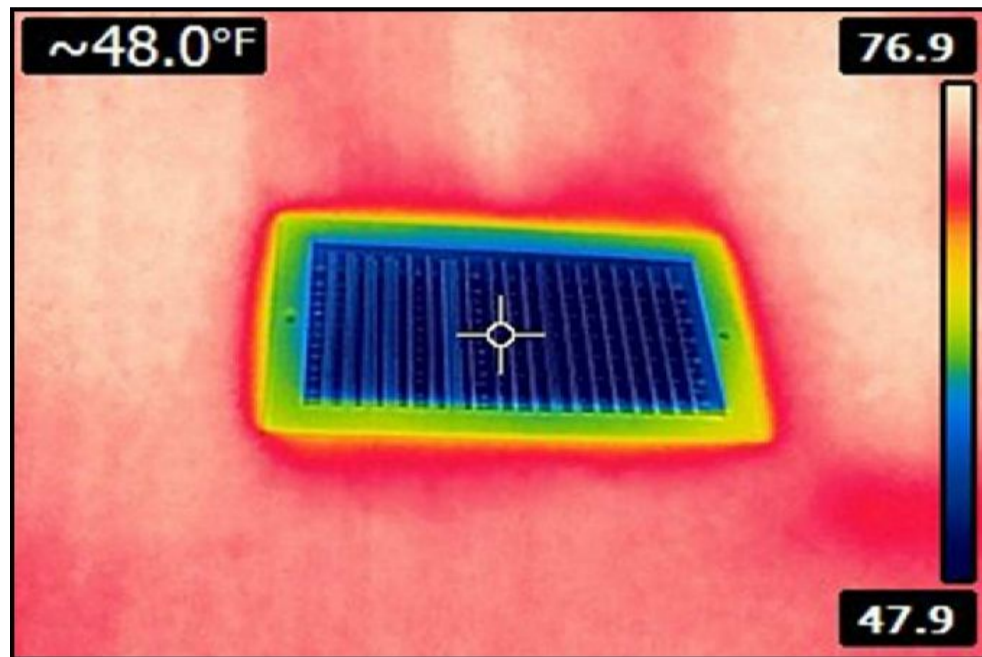
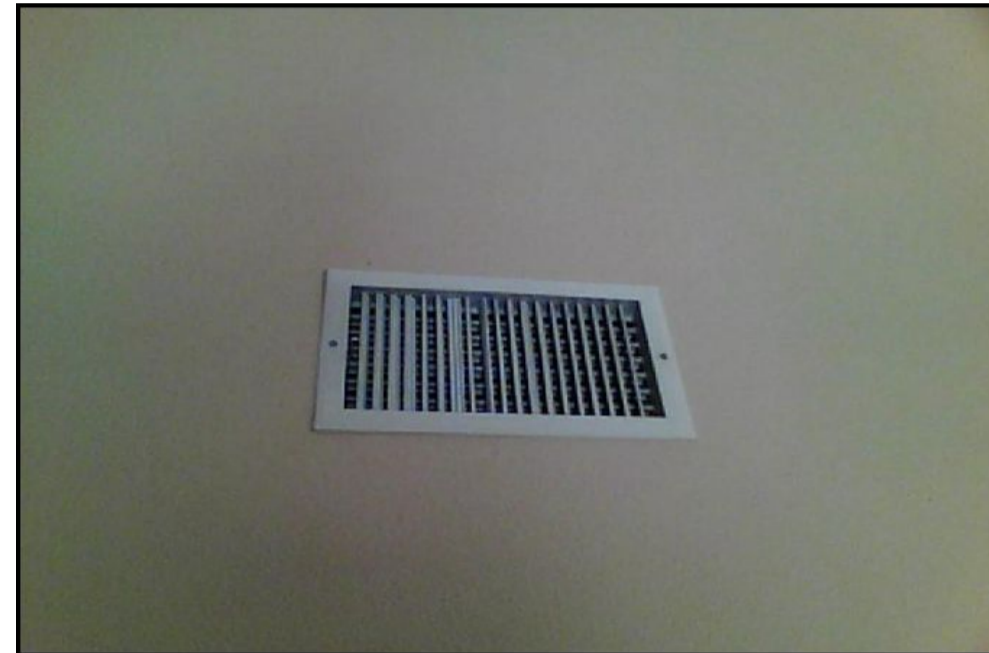
INFORMATIONAL 9.6. The air conditioning unit for the premises is provided by a central air conditioner which is located at the exterior.

INFORMATIONAL 9.7. Using an infrared handheld thermometer, the following readings were taken while the cooling system was in operation: Temperature at Return: 76 degrees. Temperature at Register: 48 degrees.

SATISFACTORY 9.8. At the time of the inspection, the cooling system appeared to be in satisfactory condition.

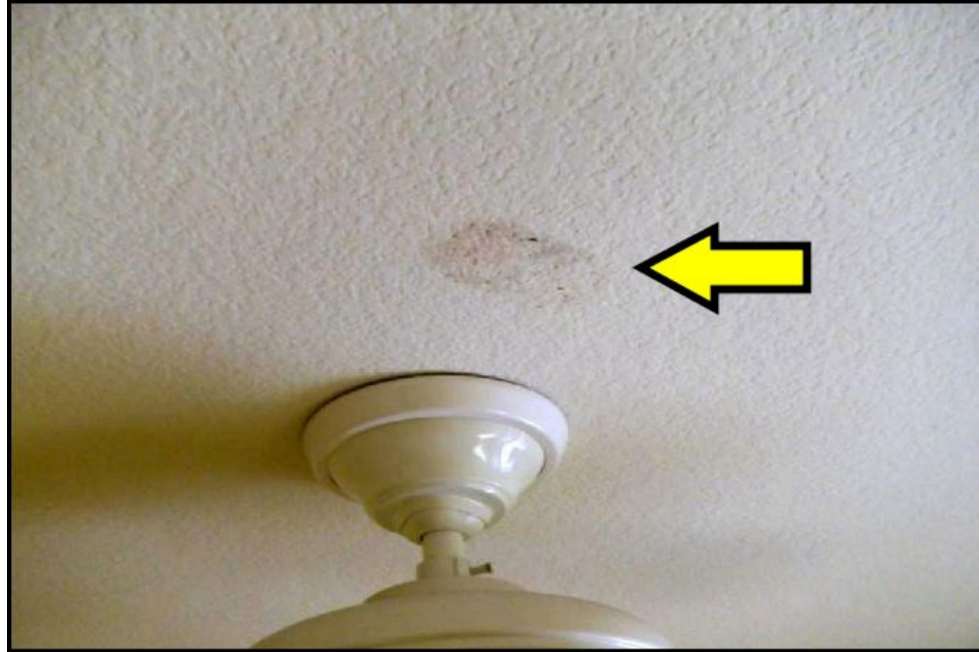
NEEDS ATTENTION 13.8. There are water stains at the ceiling in this room. Since the inspector is unable to determine the cause of this staining (e.g., plumbing leak; roof leak if roof is above this ceiling) or whether the cause of the staining has been remedied, we recommend further evaluation to rule out any possible moisture intrusion issues.

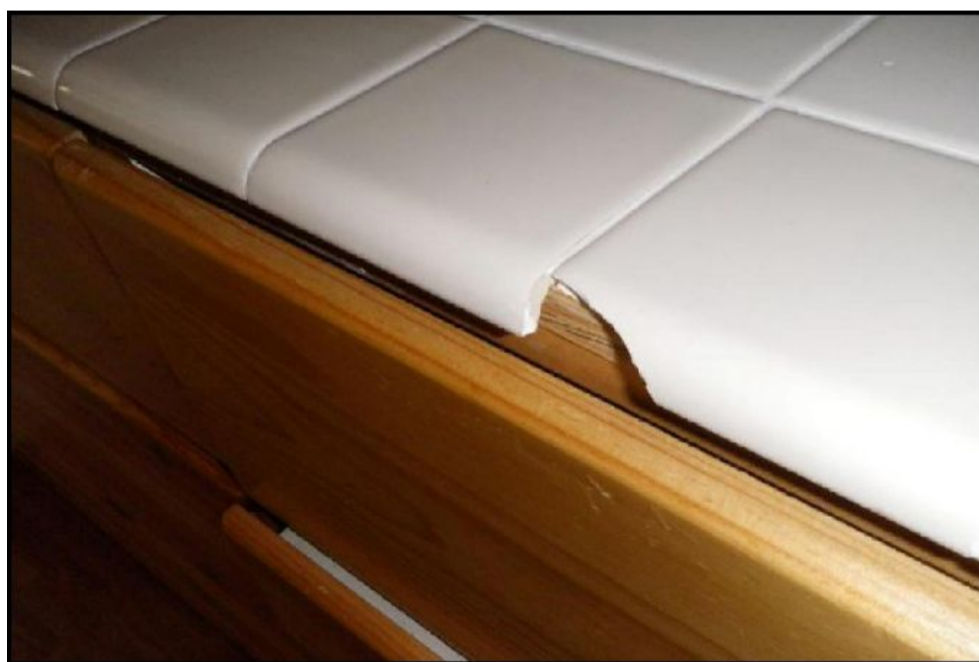
NEEDS ATTENTION 14.3. One or more of the counter tiles are cracked or chipped.

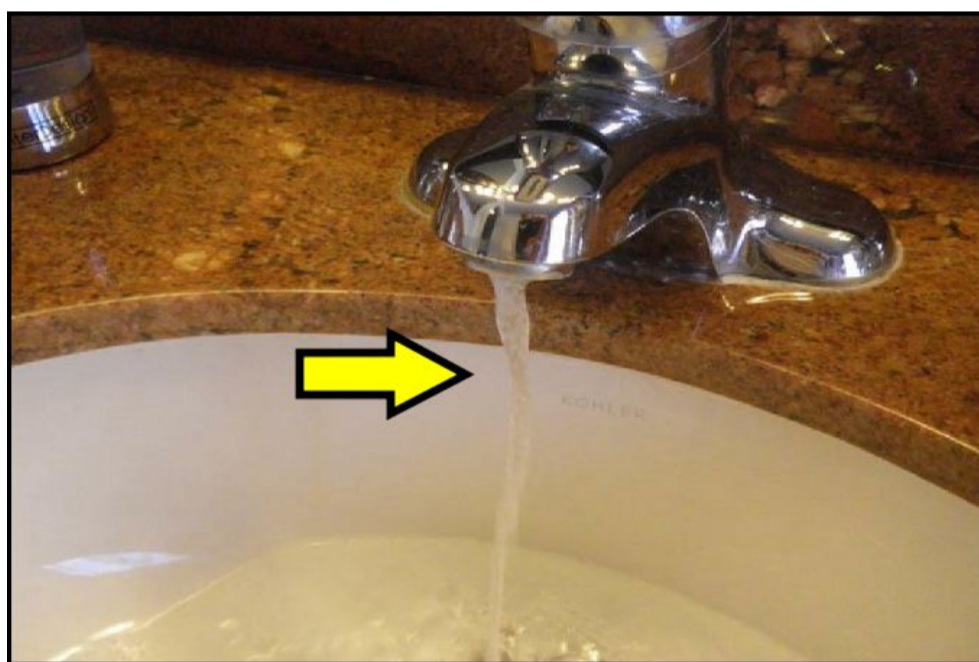
NEEDS ATTENTION 15.3. Low water flow was observed at the sink faucet. Typically, a defective faucet valve or a problem in the supply line to this fixture is the cause when low flow is not also observed in other fixtures of the house. Possible additional causes *if low flow is flagged in other bathrooms/kitchen:* outdated/aged plumbing lines; water regulator issues.

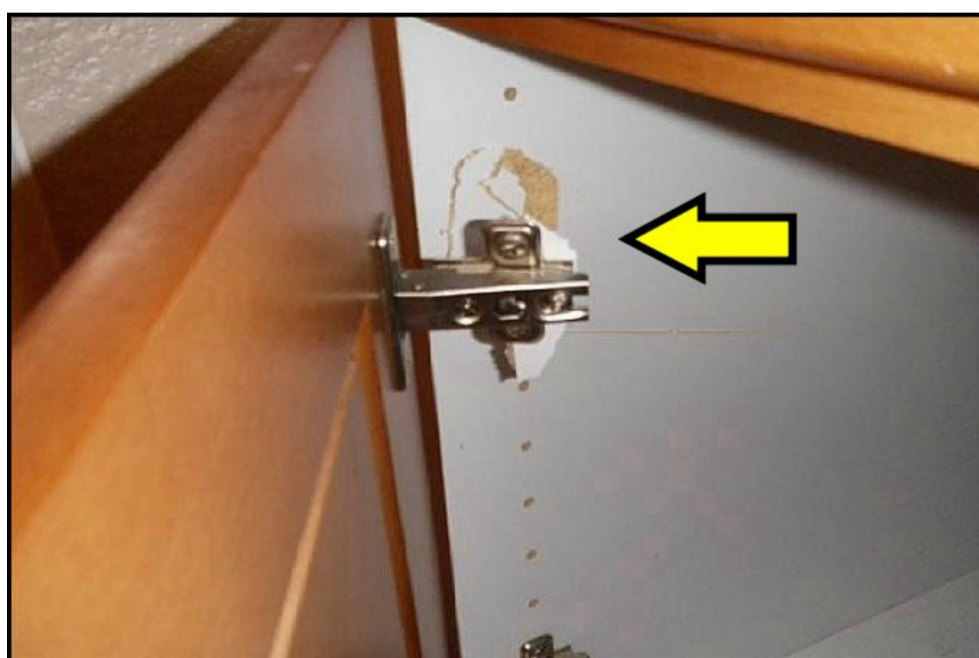
NEEDS ATTENTION 15.4. One of the bathroom cabinet doors has a damaged hinge and will need servicing.

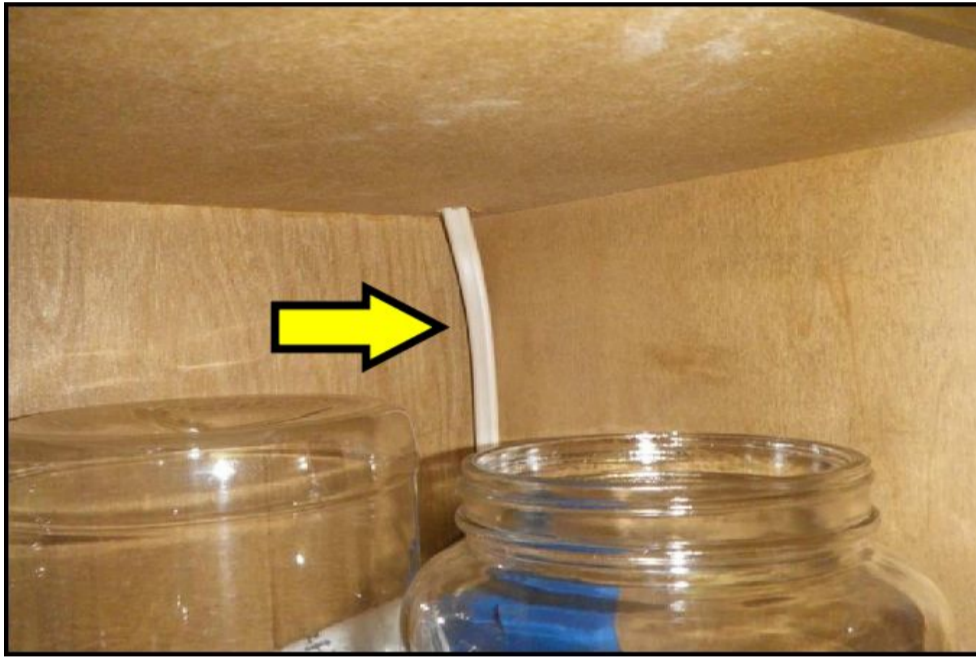
NEEDS ATTENTION 15.7. There is exposed wiring in the bathroom that should be addressed by an electrician for electrical safety reasons.

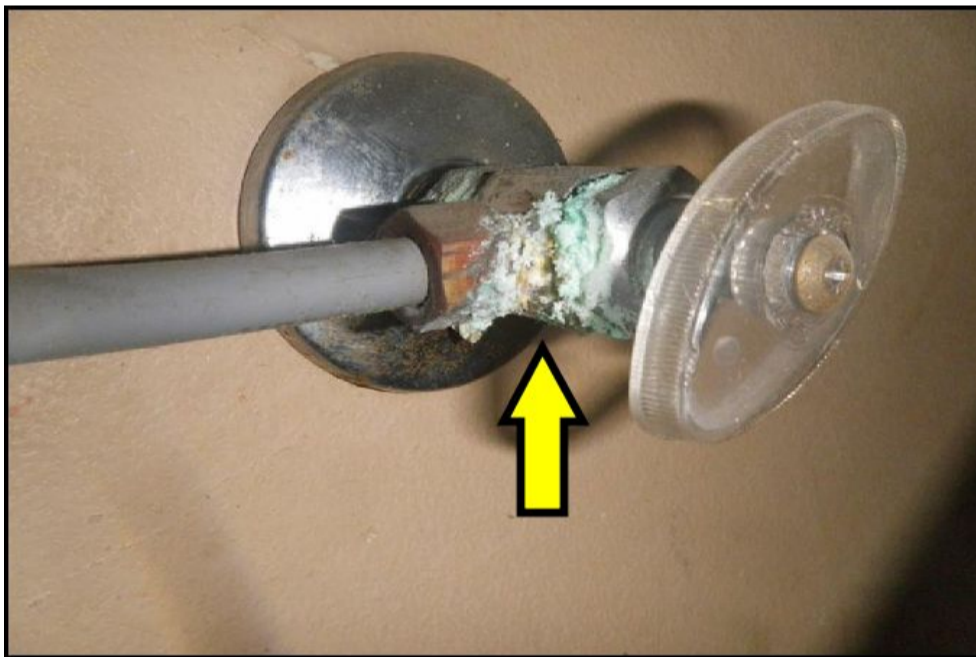
NEEDS ATTENTION 15.8. Corrosion was found at the water supply line(s) under the sink. Left uncorrected, these lines may eventually leak and lead to moisture intrusion problems (e.g., wood damage, mold).
